Technical Service Bulletin

Mazda North American Operations
Irvine, CA 92618-2922

Subject: VOICE RECOGNITION SYSTEM DOES NOT RECOGNIZE "ADDRESS" OR "NEW DESTINATION" NAVIGATION VOICE COMMANDS	Bulletin No.: 09-003/18
	Last Issued: 01/16/2018

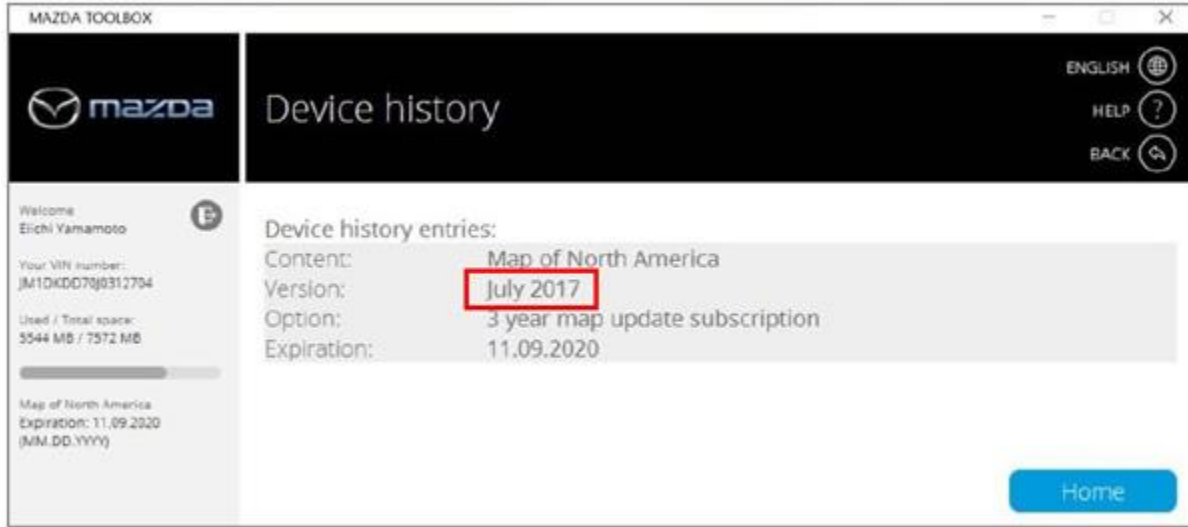
3. Using Mazda Toolbox, open the "Device History" screen and check the SD Card version.

Is the SD Card version before July 2017?

- Yes - Update Navigation SD card to the latest software using Mazda Toolbox.
- No - This service information does not apply. Refer to MGSS online for normal diagnosis procedures.
