Technical Service Bulletin

| Subject: FORWARD SENSING CAMERA (FSC) RELATED CONCERNS (FSC) | Bulletin No.: 15-001/18 |
| | Last Issued: 01/18/2018 |

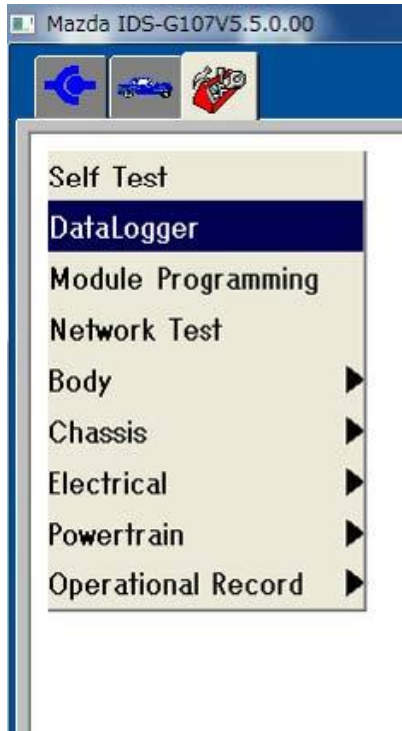
4. If the FSC seems to be hot [140 °F (60 °C) or higher], cool it down by parking the vehicle in the shade with the ignition OFF.

NOTE: If the FSC is hot, the FSC reprogramming process may fail. The FSC temperature can be monitored using the data logger function of the M-MDS. "C_SCORE" has to be 174 or higher to reprogram the FSC.
