IMPORTANT WARRANTY INFORMATION

REF **15-010**
 Effective 03/30/2015
 Release 03/30/2015
 SUBJECT Transmission Cooler Line Photos

❖ Transmission Cooler Line Photos Requested

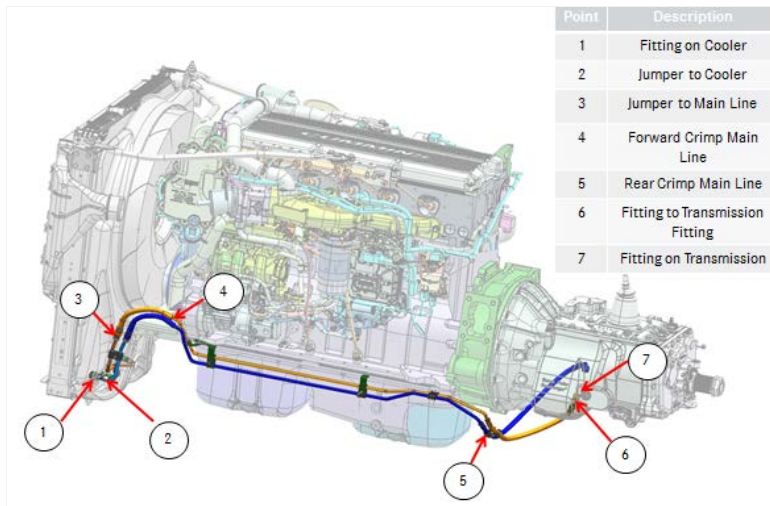
DTNA Warranty Engineering has identified seven (7) potential transmission cooler leak areas, as indicated in the graphic below, where having claim photos would be particularly beneficial:

| • Fitting on cooler | • Rear crimp main line |
| • Jumper to cooler | • Fitting to transmission fitting |
| • Jumper to main line | • Fitting on transmission |
| • Forward crimp main line | |
