Coronado
Business Class M2
> Cascadia
108SD/114SD

**Freightliner
Service Bulletin**

Quarter Fender Reinforcement

31-30

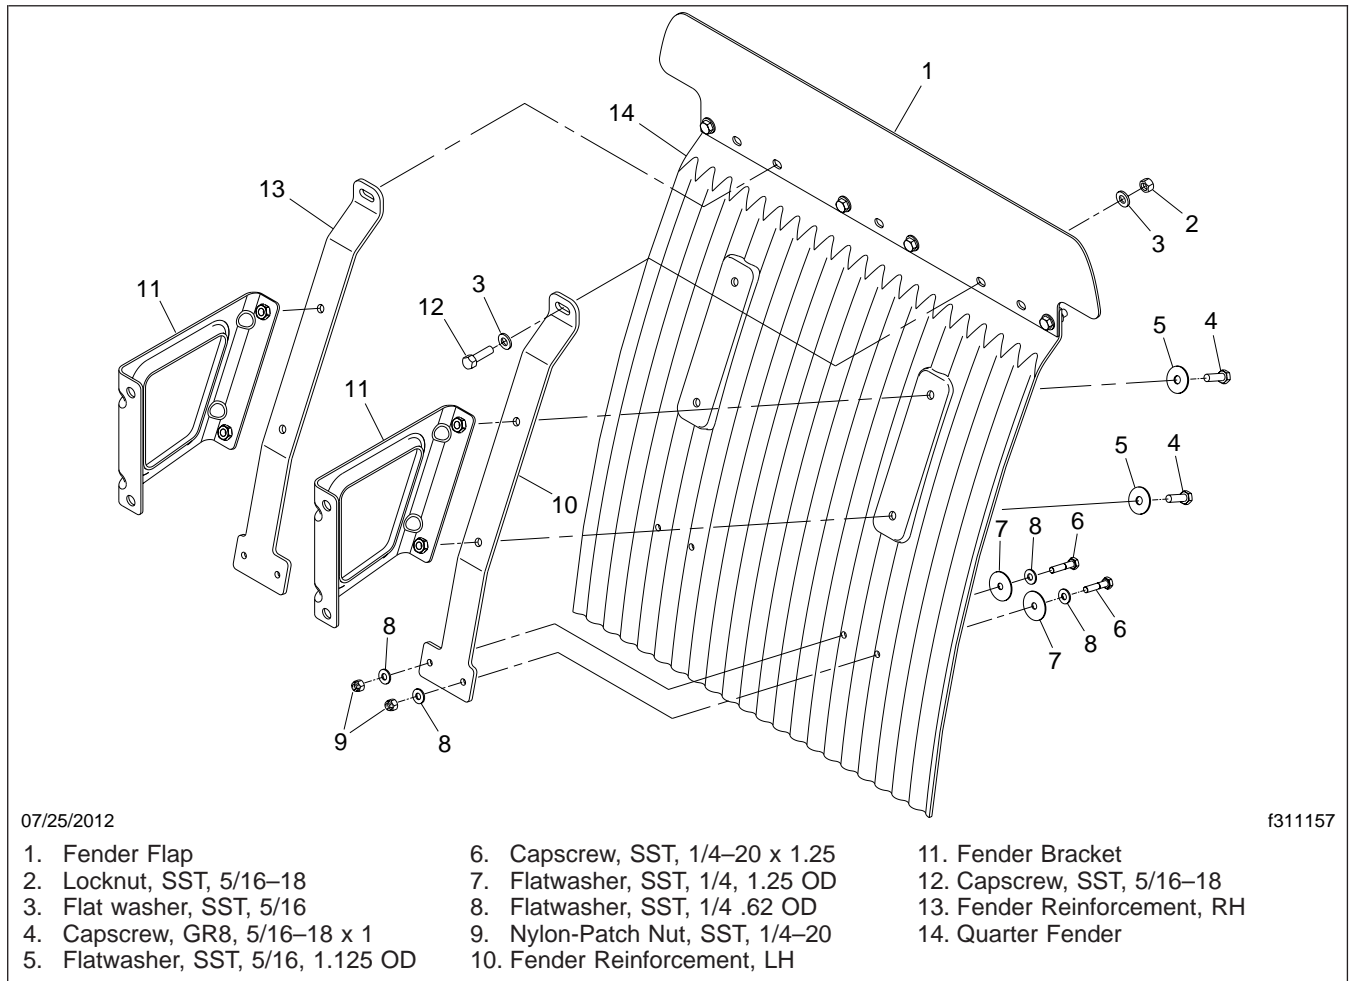
Fig. 1, Quarter Fender Reinforcement Installation

On some Cascadia vehicles built with full-length chassis side fairings, the rear quarter fenders may crack at the fender mounting. A steel reinforcement is available to improve the durability of the quarter fender mounting. See **Fig. 1**. When replacing a rear quarter fender, it is recommended that the additional steel reinforcements also be installed.

5. Position the quarter fender reinforcements on the new quarter fender. The longer toe of each reinforcement should point inward. See [Fig. 1](#) for orientation. Attach each reinforcement to the top of the fender at the fender flap and hand-tighten the fasteners.

8. Install the fasteners with the 1.25 OD washers touching the quarter fender plastic, and the .62 OD washers between the larger washers and the capscrew head. Install the bracket-side nuts with .62 OD washers. See [Fig. 1](#). Tighten the fasteners 4 to 6 lbf-ft (5.5 to 8 N-m).
9. Tighten the two top fasteners 6 to 8 lbf-ft (8 to 11 N-m).
10. Install the quarter fender assembly onto the mounting bracket, and tighten the mounting fasteners 6 to 8 lbf-ft (8 to 11 N-m).
