February 27, 2018

08342 Version 2

2016–17 Pilot: Judder from the Torque Converter Lock-Up Clutch After Software Update (Snapshot Upload Required)

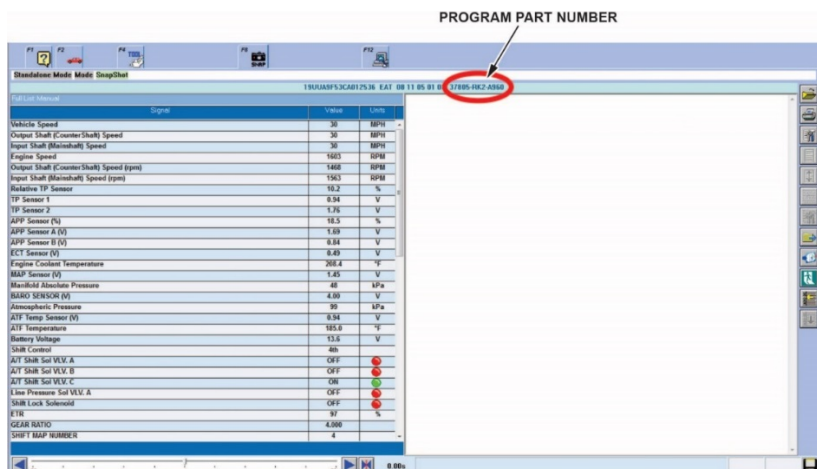
1. Connect the i-HDS, and go to the A/T Data List. Check to see if the software has been updated by comparing the program P/N against the table below.
