Applies To: **See VEHICLES AFFECTED**

February 13, 2014

MIL Is On With DTC P0420 or P0430

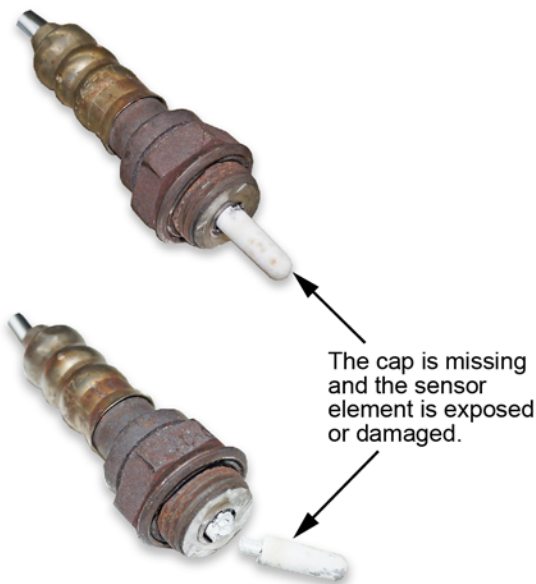
NO GOOD

One or both primary A/F Sensor (Air Fuel Ratio) caps may have fallen off and bored a hole through the affected WU-TWC (Warm Up Three Way Catalyst).

3. Check for a missing cap from the primary A/F sensor.

Replace the affected primary A/F sensor and WU-TWC, then find the missing A/F sensor cap from the under floor TWC.

- If DTC P0430 is stored and the cap is missing from the front (bank two) primary A/F sensor, go to REPAIR PROCEDURE A.
- If DTC P0420 is stored and the cap is missing from the rear (bank one) primary A/F sensor, go to REPAIR PROCEDURE B.
- If the cap is not missing, this bulletin does not apply. Continue with normal troubleshooting.
