Technical Service Bulletin: TSB170047	Released Date: 18-Jan-2018
Aftertreatment System Alignment Arrows Misaligned on Firetruck Applications

Aftertreatment System Alignment Arrows Misaligned on Firetruck Applications

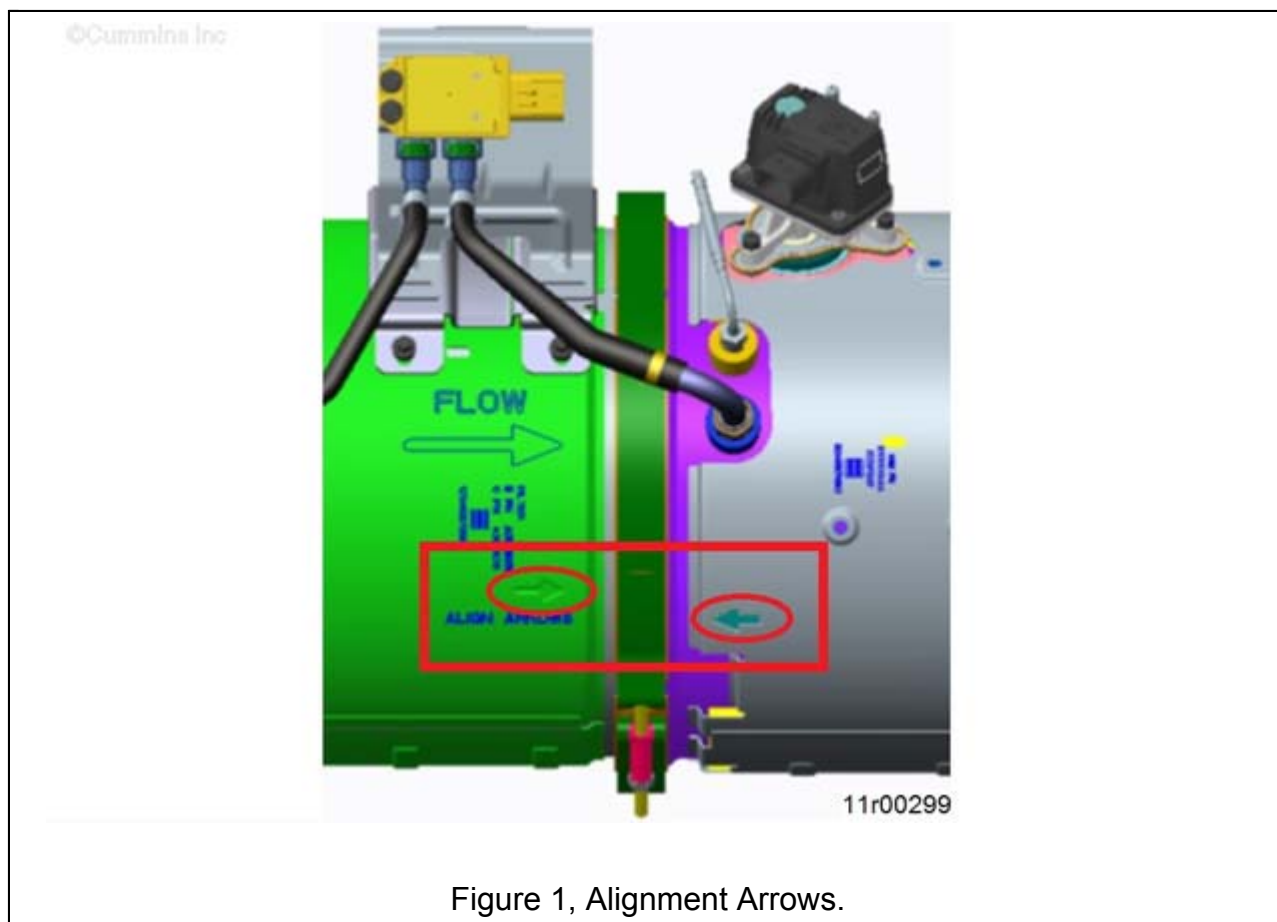
Figure 1, Alignment Arrows.

Alignment arrows on aftertreatment diesel particulate filter (DPF) and aftertreatment decomposition tube are intentionally misaligned by approximately 10 degrees. See Figure 1 below.

If aftertreatment DPF and aftertreatment decomposition tube alignment arrows are in alignment, differential pressure sensor tube connected to aftertreatment decomposition tube will not fit properly and can become kinked and/or bent.

- Misalignment of aftertreatment DPF and aftertreatment decomposition tube is required to allow for adequate aftertreatment system clearance in this application.
- Prior to loosening or removal of aftertreatment v-band clamp, aftertreatment DPF, or aftertreatment decomposition tube; an orientation reference line **must** be drawn across aftertreatment DPF, v-band clamp, and decomposition tube to aid in assembly.
- Use orientation reference lines added prior to loosening or removal to assist in correct differential pressure sensor tube alignment during assembly.
