TECH TALK

Volume 236 - January 2018

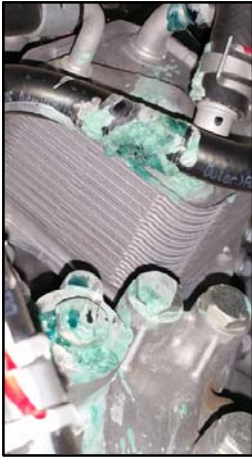
COOLANT LEAKS AT CVT8 FLUID COOLER HOSES — 2016-18 Outlander.

When encountering coolant leaks from the CVT8 fluid cooler hoses on affected Outlander models, please take clear focused photos of the affected area and post the photos into the PRC prior to repairs. Please submit a PQR on these conditions as well, making note on which hose is actually leaking.

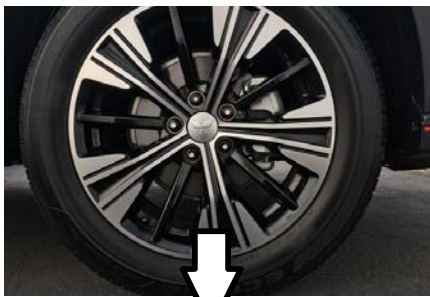
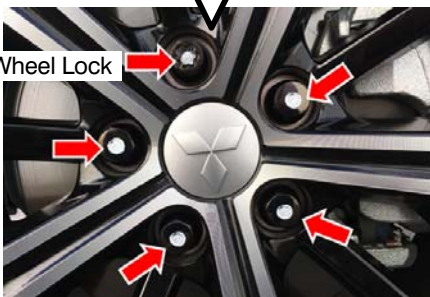
Accessory Black Wheel Lugs & Wheel Lock

TIN-17-31-002: ACCESSORY BLACK WHEEL LUGS AND LOCK EXHIBITING WHITE PAINT MARKS — 2018 Eclipse Cross, Outlander Limited Edition, Outlander Sport Limited Edition, Outlander PHEV Equipped with Accessory Black wheel lugs and lock.

TIN-17-31-002 was released recently and states: "A white torque check paint mark is added onto each black wheel lug and lock after it has been properly torqued to specification.

When taking receipt of vehicles equipped with black wheel lugs and lock, please immediately clean off all white paint marks using a wash cloth."

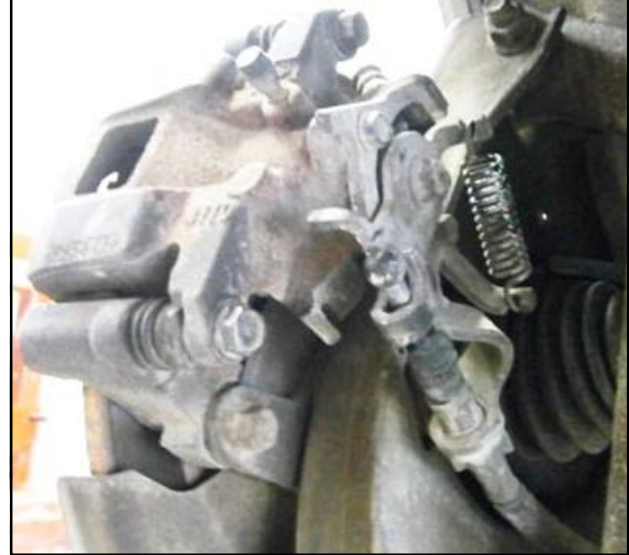
PARKING BRAKE DOES NOT HOLD — 2014-18 Outlander w/out electric parking brake.

For customer complaints of the parking brake not holding or not operating correctly, please take photos of the parking brake lever and cable area at the rear calipers with the parking brake lever NOT engaged. Please take photos of the left rear and right rear area, and post in the PRC. See photo below for an example of the parking brake lever stuck with the parking brake system not engaged.

NG Condition: Parking Brake Lever Stuck

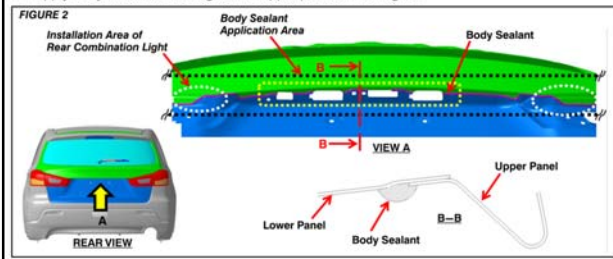
Step 4 in TSB-17-42A-001

REPLACEMENT OF LIFTGATE DOES NOT REQUIRE SEALER LISTED IN TSB-17-42A-001 — 2011-15 Outlander Sport/RVR.

The service part liftgate, part number 5801B862, does not require the application of seam sealer, shown in step 4 of TSB-17-42A-001. This hatch is built with a different material and does not require the sealer.

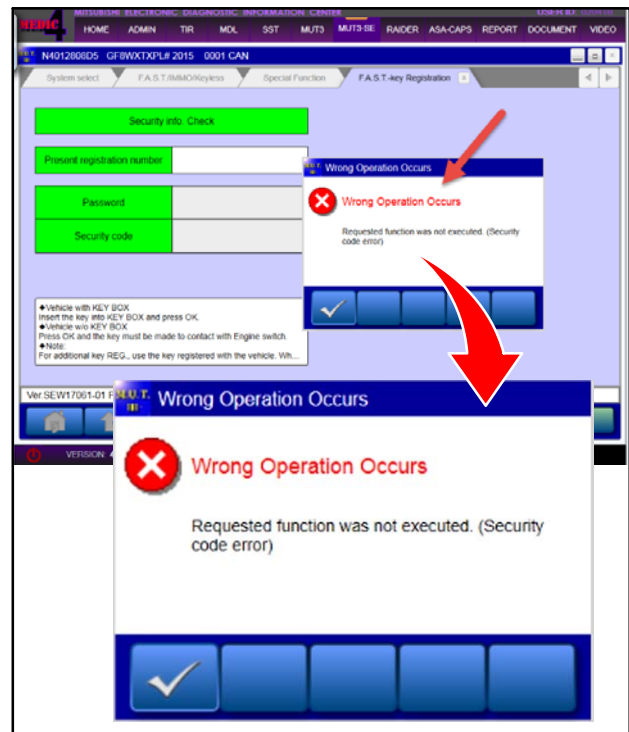
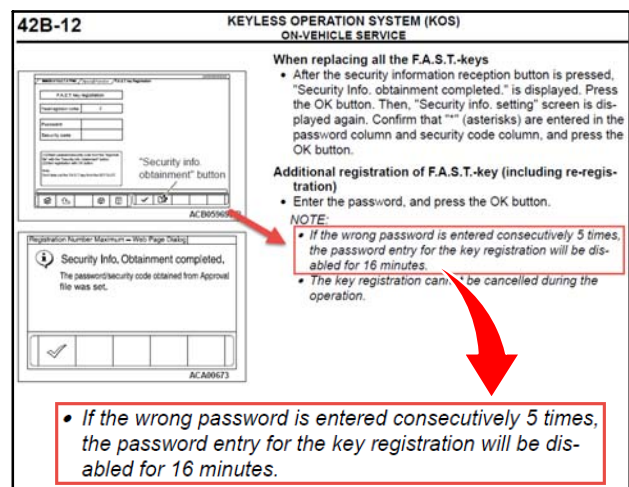
1. Wrong Operation Occurs (pop-up)

This screen will pop up if there were too many incorrect key registration attempts. Refer to the service manual - ID Codes Registration Instructions located on the MDL > service tech resource page to return (reset) the OSS-KOS system back to normal registration mode.

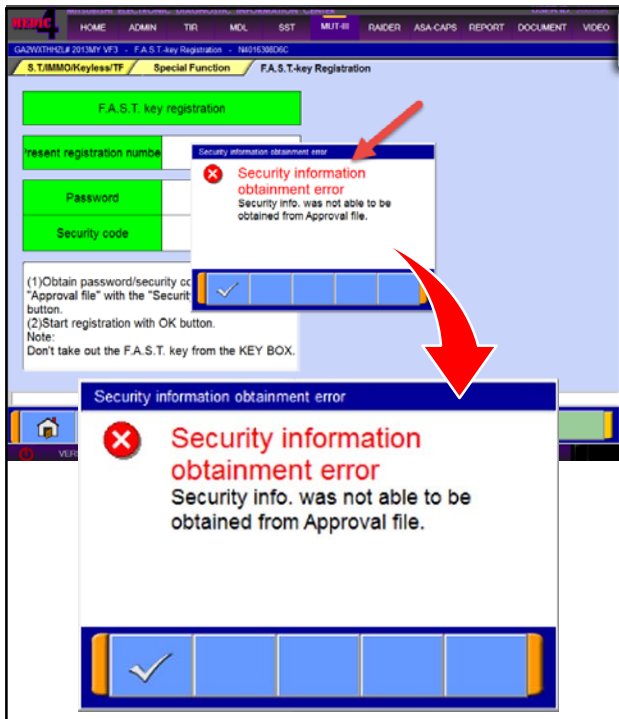
2. Security information obtainment error (pop-up)

This screen will pop up if downloaded security permission file from the MDL was either the wrong file or the correct file but was corrupted or damaged during the transfer process. Follow the procedure from Tech Talk 226 (reprinted below) on getting a generated file from the vehicle and attaching it to the Techline case.

Note: The new permission must be used with the same key FOB that was used to create the generated file, otherwise he will get another error screen stating the incorrect FOB.

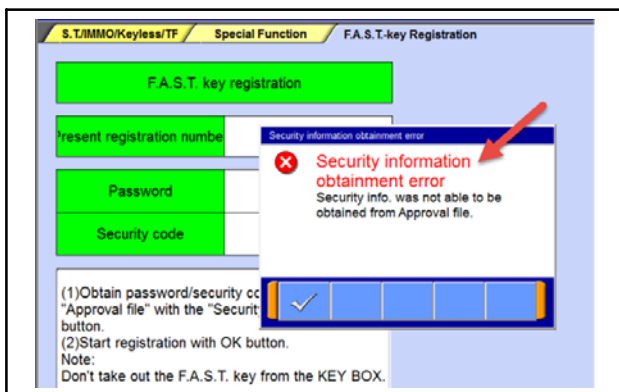
When all keys are lost, a security permission file is required to gain access to the KOS system of the vehicle to program new keys. A *Security Information Obtainment Error* may be encountered during key registration (see error message below).

This occurs when the downloaded security permission file (not to be confused with the Key Registration Password) for the vehicle is incorrect or corrupt.

If you run across this error using the downloaded security permission file, use the following steps to obtain a new security permission file.

1. Download the security permission file again and attempt to use it again to confirm the file is not working correctly.
2. Confirm you are seeing the error screen shown above.
3. Once the error screen is confirmed, generate a *Security application file* from the vehicle. This file will be used to obtain a new security permission file.

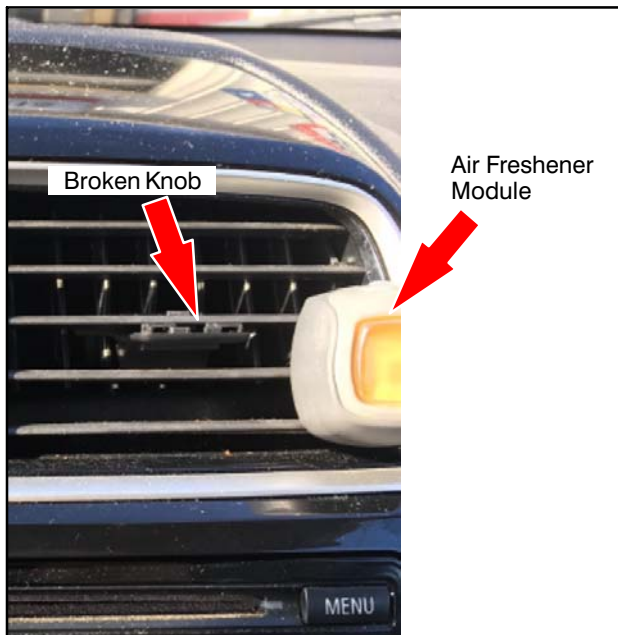
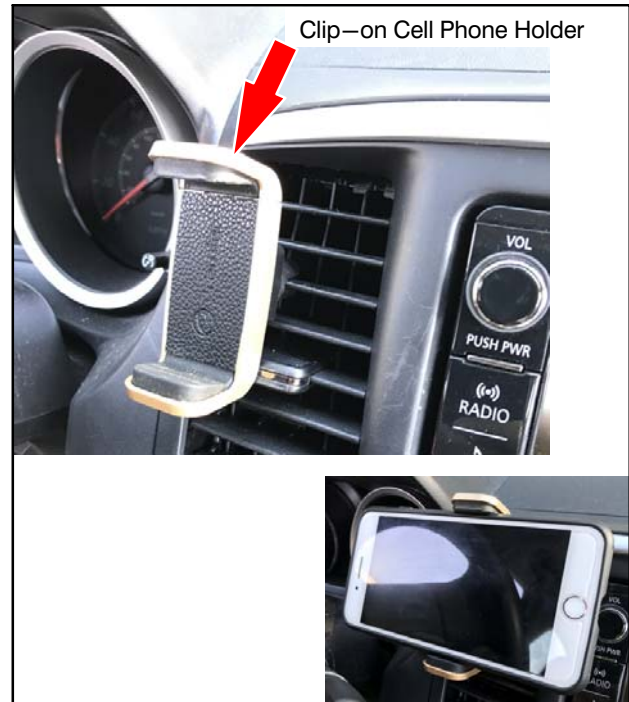
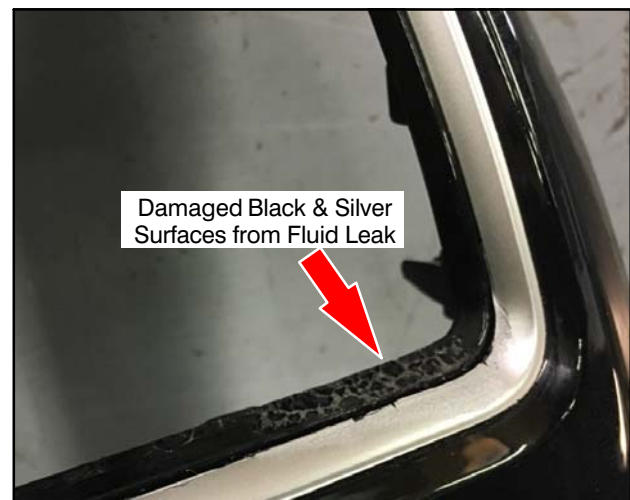
CLIP-ON AIR FRESHENER MODULES & CELL PHONE HOLDERS CAN DAMAGE HVAC VENTS — All models.

Installation and removal of air freshener modules and cell phone holders can dislodge the horizontal vent fins and the internal vertical vent fins or can damage the vent adjustment knobs. Normal adjustment of the vents can also be blocked by these 2 components.

Additionally, if an air freshener module leaks, the scent fluid can damage the surface of surrounding trim. Replacement of the instrument panel center vents includes the radio control panel in some models and is expensive.

Notify the customer with vent or surrounding trim appearance issues, that use of air freshener modules and cell phone holders can cause damage, and repair for this type of damage is **not** covered by warranty.

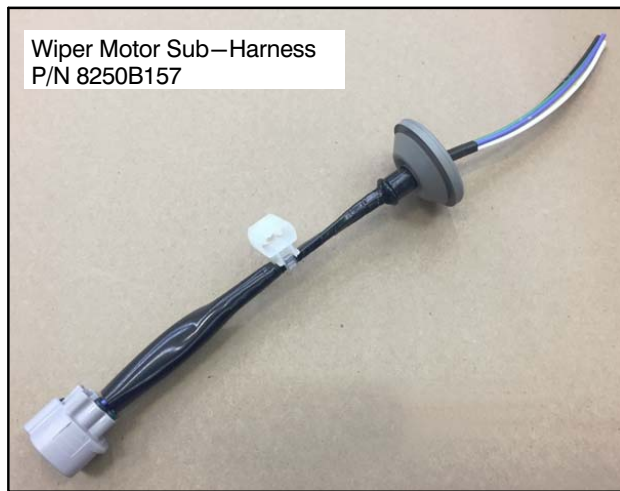
WINDSHIELD WIPER MOTOR SUB-HARNESS WITH CONNECTOR (PIGTAIL) AVAILABLE — 2011-15 Outlander Sport/RVR.

In case you find damage to the wiper motor connector (harness side), it is no longer necessary to attempt connector repair or harness replacement. A sub-harness with connector is now available as a separate spare part with P/N 8250B157.
