# Technical Bulletin

**26 16 06** November 14, 2016 **2039436** Supersedes Technical Bulletin V261603 dated June 20, 2016 to clarify reductant agent quantity refill.

### AdBlue® Warning and or MIL ON – AdBlue® Leakage at Reductant Injector

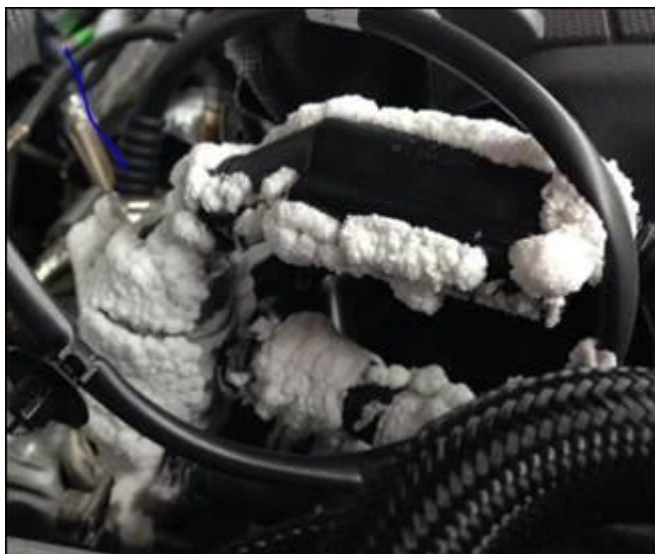
Welding process issues of the reductant line connector to the supply line may cause AdBlue® leakage at the reductant injector.

Inspect the connection of the reductant supply line connector at the reductant injector in the engine compartment. If white crystalized (dried) AdBlue® is found at the reductant injector (see Figure 1 & 2), it will be necessary to replace the reductant supply line.

- Thoroughly clean the area of the reductant supply line connection with water to remove the crystalized AdBlue®.
- Replace the reductant supply line.
- Refill reductant agent as required per part table quantity.

It is not necessary to replace the reductant injector.
