# Technical Service Bulletin

## 01 MIL on (DTC P2440(00) and/or P2442(00))

01 16 88 2040403/4 November 28, 2016. Supersedes Technical Service Bulletin Group 01 number 16-73 dated August 10, 2016 for reasons listed below.

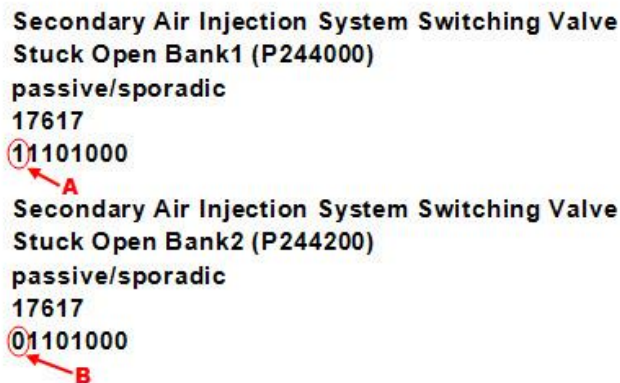
- One or both of the DTCs listed in the *Condition* is stored.
- The bit for MIL on shows “1” for one DTC only (Figure 1).

**Figure 1.** In this example, both DTCs are stored. The bit for MIL on with DTC P244000 (A) shows “1”, which means this DTC caused the MIL to illuminate. The bit for MIL on with DTC P244200 (B) shows “0”, which means it did not cause the MIL to illuminate.

- Replace the combi valve of the bank with the DTC that caused the MIL to illuminate.

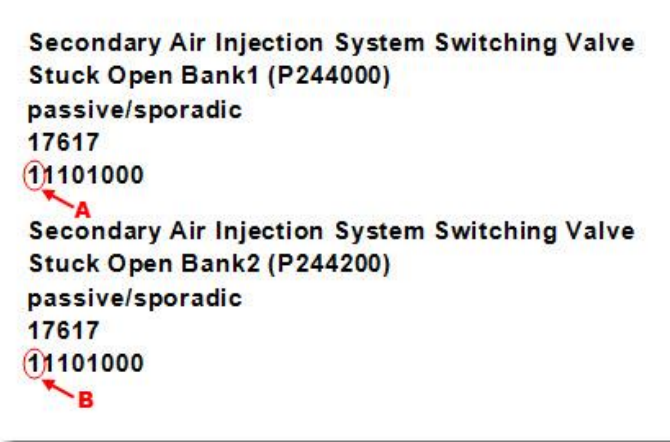
- Both of the DTCs listed in the *Condition* are stored.
- The DTCs were stored at the same time.
- The bit for MIL on shows “1” for both DTCs.

**Figure 2.** In this example, both DTCs are stored. The bit for MIL on shows “1” for both DTCs (A and B).

Replace the vacuum solenoid valve that controls both of the combi valves.
