Technical Service Bulletin

26 Vibrations between 1000 and 3000 rpm while driving

26 16 30 2045720/2 November 17, 2016. Supersedes Technical Service Bulletin Group 26 number 16-29 dated October 25, 2016 for reasons listed below.

Model(s)	Year	VIN Range	Vehicle-Specific Equipment
A8, S8	2013 - 2015	All	4.0 liter TFSI
A8	2016	000001 - 014321	4.0 liter TFSI
S8	2016	900001 - 900386	4.0 liter TFSI

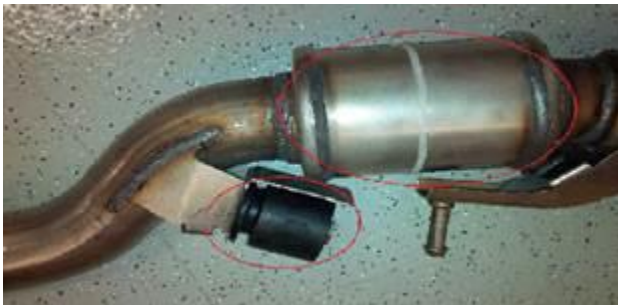
With time the decoupling element of the front muffler fails to dampen the vibrations of the front exhaust pipe.

Figure 1. Dampening weight and shipping sleeve on decoupling element.

Replace both exhaust pipes with front mufflers with the part numbers listed in ETKA with a VIN specific search of the catalog. The new pipes will come with a shipping sleeve around the decoupling element which needs to be left on the element until the pipes are installed on the vehicle (Figure 1).

- Decoupling element must not be bent more than 10 degrees.
 - Do not damage wire mesh at decoupling element.
1. Align the exhaust system free of tension. Refer to Elsa→ *Chapter 26> Exhaust System, Emission Controls > Exhaust Pipes/Mufflers > Exhaust System, Installing without Tension.*
 - Remove the shipping sleeves from both pipes.
 2. Confirm that TSB 2036392 - Software update J931 (address word BA) has been performed.
 3. Test drive vehicle until engine is at operating temperature.
 4. Perform J931 (address word BA) basic setting and road test.
