Technical Service Bulletin

91 Rearview camera intermittently inoperative (DTC 02283)

91 16 88 2045927/1 November 11, 2016.

Model(s)	Year	VIN Range	Vehicle-Specific Equipment
A5	2008 - 2017	All	Rearview camera
A5 cabriolet	2010 - 2017	All	Rearview camera

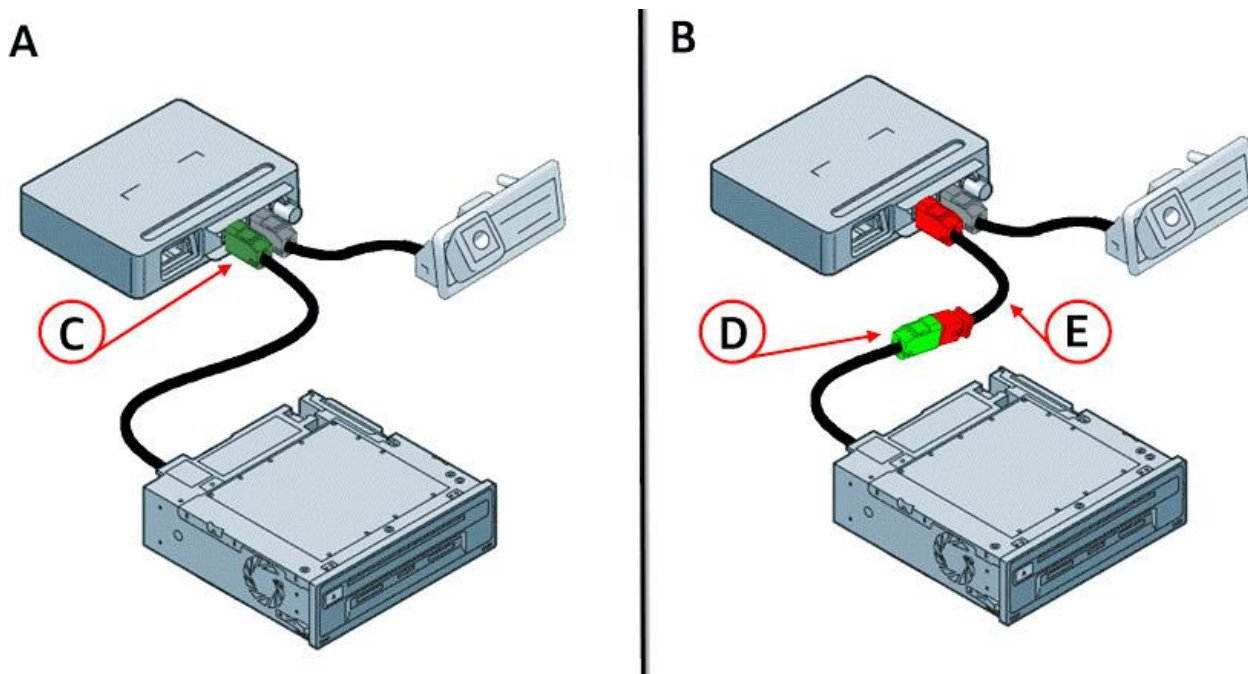
Figure 1. Image A: original reverse camera image wiring configuration. Image B: modified reverse camera wiring configuration. Modified wiring configuration replaces original green Fakra connector terminal (C) by installing aerial plug adapter 8T0971192 (E). Original harness is modified with the installation of a new female Fakra connector terminal (D).

2. After the concern has been duplicated, and isolated to the Fakra connector at the rearview camera system control module J772 (address word 006C). A replacement of the green Fakra connector must be made:
 - Aerial plug adapter 8T0971192 will need to be installed (Figure 1B, Image E).
 - A new female coax terminal 000979910 and connector 6Q0035576K will need to be installed on the vehicle harness (Figure 1B, Image D).

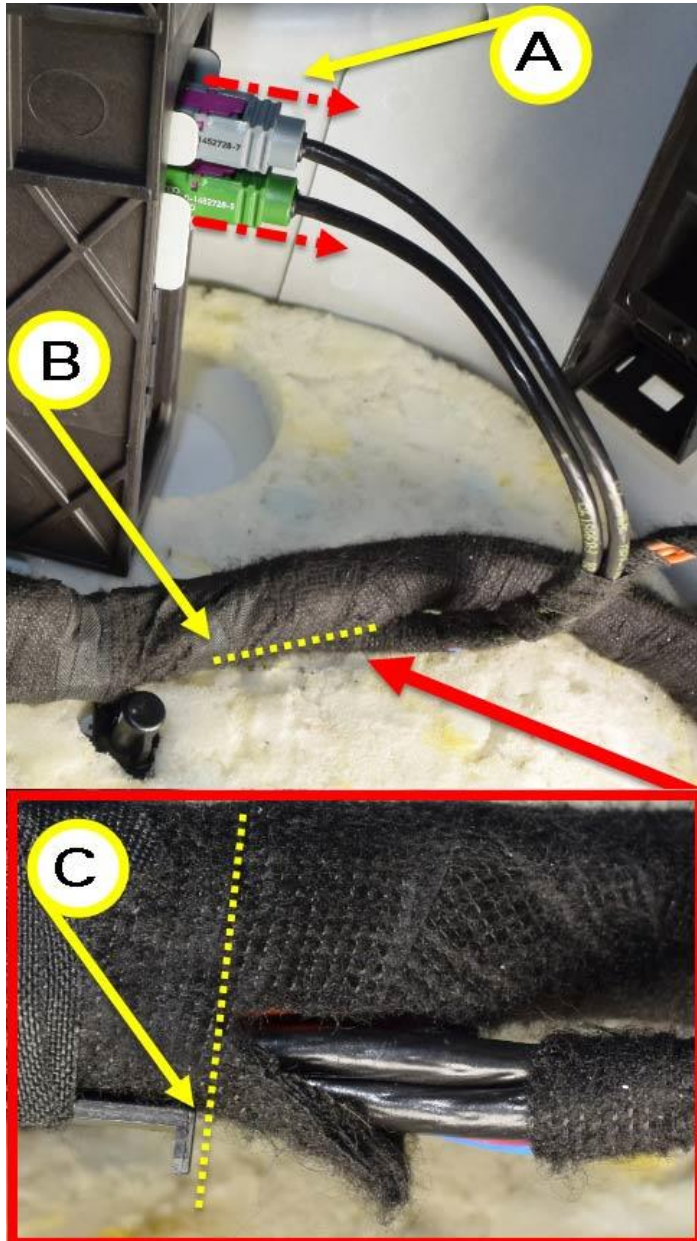
Figure 2. Unplug both the green and grey Fakra connectors from the rearview camera system control module (A). Open the body harness along the path of the coaxial wiring by carefully cutting the fleece

adhesive tape of the body harness. This cut line is represented by dotted line (B). The cut line stops at the end stop of the harness retainer, shown by dotted line (C).

- Unplug both the green and grey Fakra connectors from the reversing camera control unit (Figure 2, Image A).
- Open the body harness along the path of the coaxial wiring by carefully cutting the fleece adhesive tape of the body harness (Figure 2, Image B).
- Cut the fleece adhesive tape back to the end stop of the harness retainer clip (Figure 2, Image C).

Be sure to utilize lacing tape cutters, or similar tooling when removing the fleece tape to help ensure that there is no damage to the wiring harness.

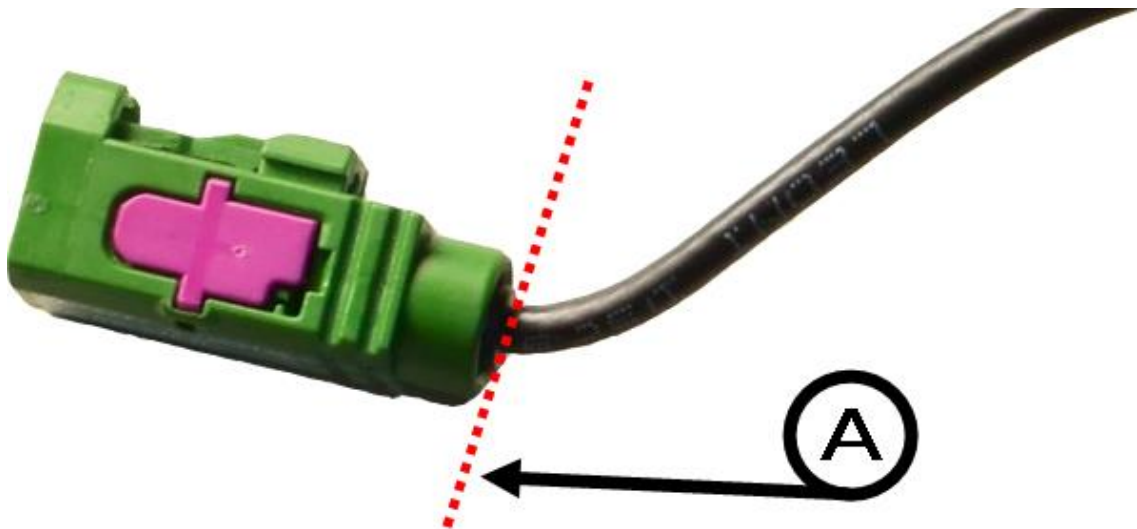
Figure 3. Cut the coax wire at dotted line (A), where it connects to the green Fakra connector.

- Cut the coax wire where it connects to the green Fakra connector (Figure 3, Image A).

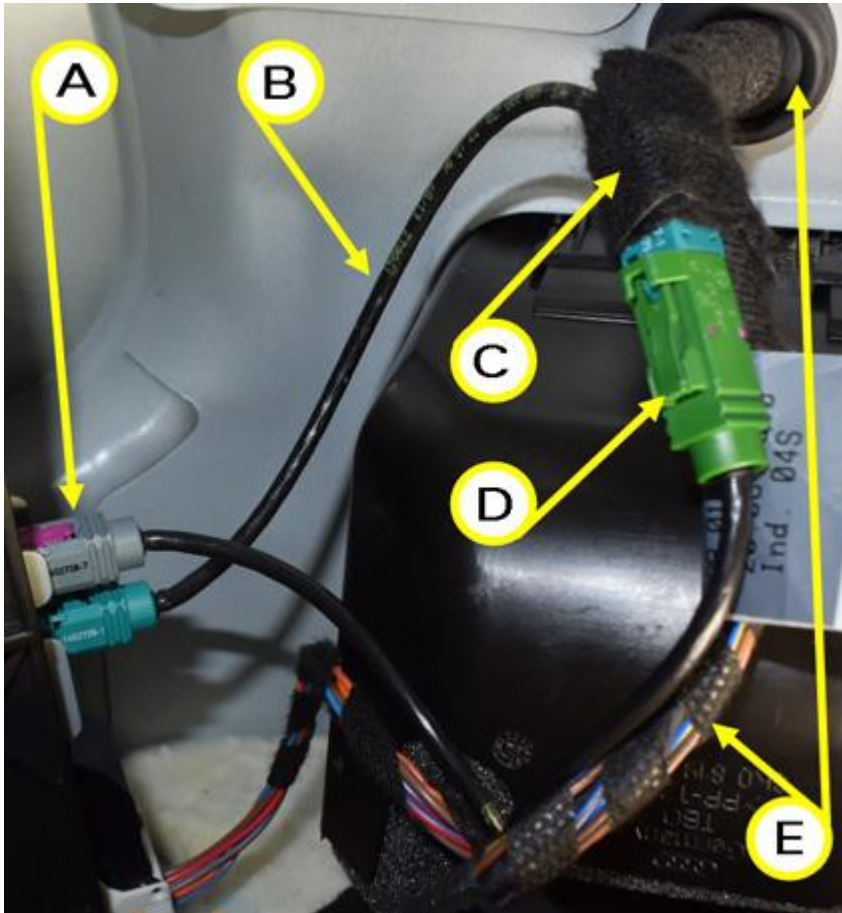
Figure 4. Reconnect grey Fakra connector (A) to the rearview camera system control module J772. Connect the aerial plug adapter 8T0971192 (B) to the rearview camera system control module J772. Connect the other end of the aerial plug adapter to the newly installed Fakra connector on the main body harness (D). Secure the new coaxial wire to the rear cover wire harness (E) with a piece of fleece adhesive tape (C). Ensure there are no kinks, bends, or strain on the coaxial wiring.

- Using the VAS 6720, crimp on a new female Fakra coax terminal.
 - Install a new plastic Fakra connector housing (6Q0035576K) onto the new terminal end.
6. Connect newly installed wiring:
- Reconnect the grey Fakra connector to the rearview camera system control module J772 (Figure 4, Image A).
 - Connect the aerial plug adapter 8T0971192 into rearview camera system control module J772 (Figure 4, Image B).
 - Connect the other end of the aerial plug adapter 8T0971192 to the terminal end installed in step 5 (Figure 4, Image D).
 - Secure the new wiring to the rear cover wiring harness (Figure 4, Image E) with a piece of fleece adhesive tape (Figure 4, Image C).
 - Ensure there are no kinks, bends, or strain on the new wiring.
