**Title (customer effect)** Aftertreatment Control Module ( ACM ) Diagnostic Trouble Codes ( DTC ) U0001-88 and U0010-88 Lighting The Malfunction Indicator Lamp ( MIL ); Possible Derate Warning – US10 And Newer Chassis

**Cause** ACM harness rubbing and chafing can cut into wires, resulting in DTCs and loss of communication with the ACM. ACM faults can result in derate conditions.

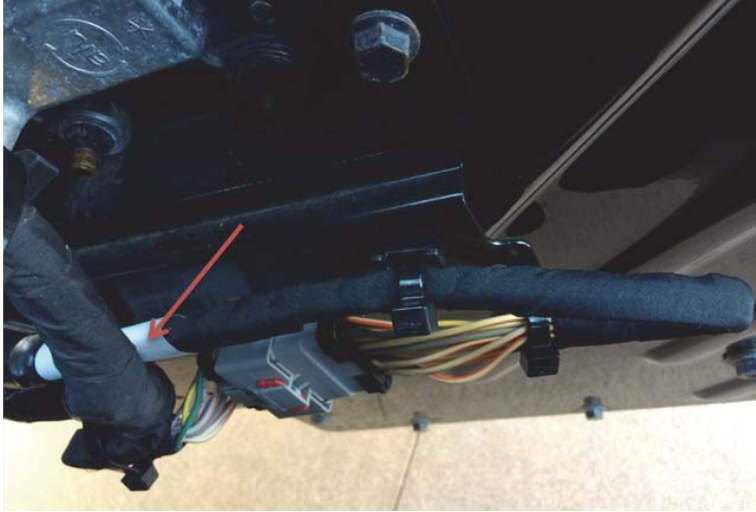
- A. Chafing or Rubbing between harnesses:

If contact between the harnesses is found, resecure them with a separator tie to keep them apart.

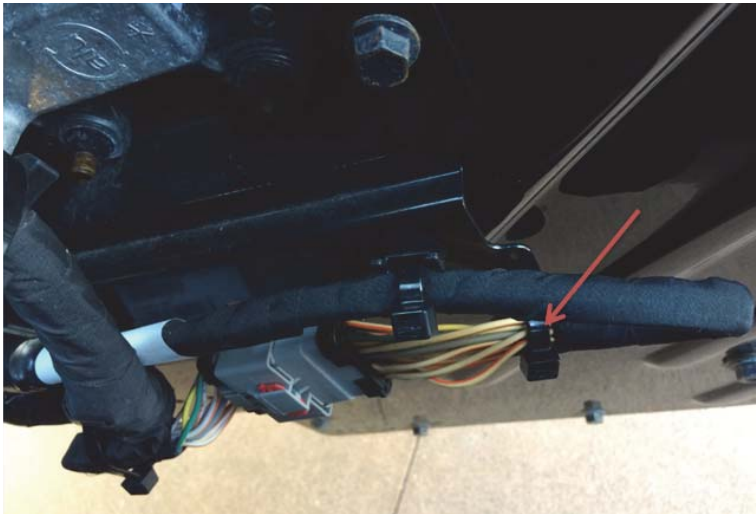
B. Chafing or Rubbing at the clipping point (cable tie) securing the harness near the FCUT connector:

If the cable tie is found to be cutting into the wire insulation, remove the cable tie, wrap the exposed wires in harness tape and re-clip the harness securely.

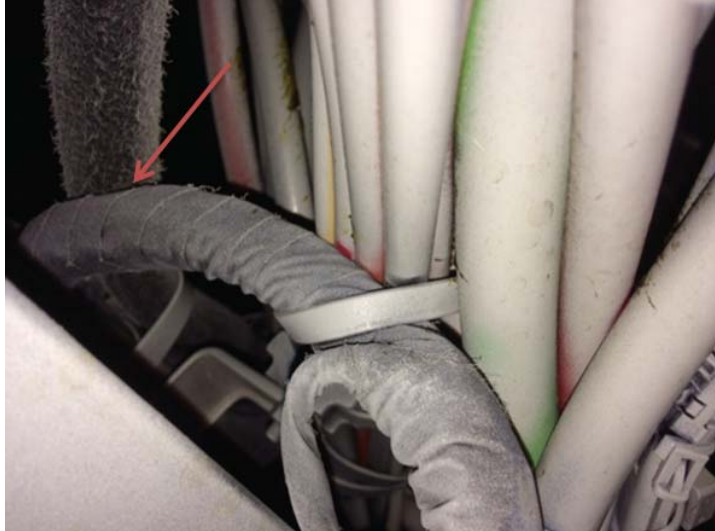
Check the section of the AHI harness that passes by the air compressor discharge line:

If the ACM harness is rubbing the air compressor discharge hose, make sure the harness is clipped to the airline bundle securely as shown above. Attach a separator tie between the harness and the discharge hose to keep the two apart.

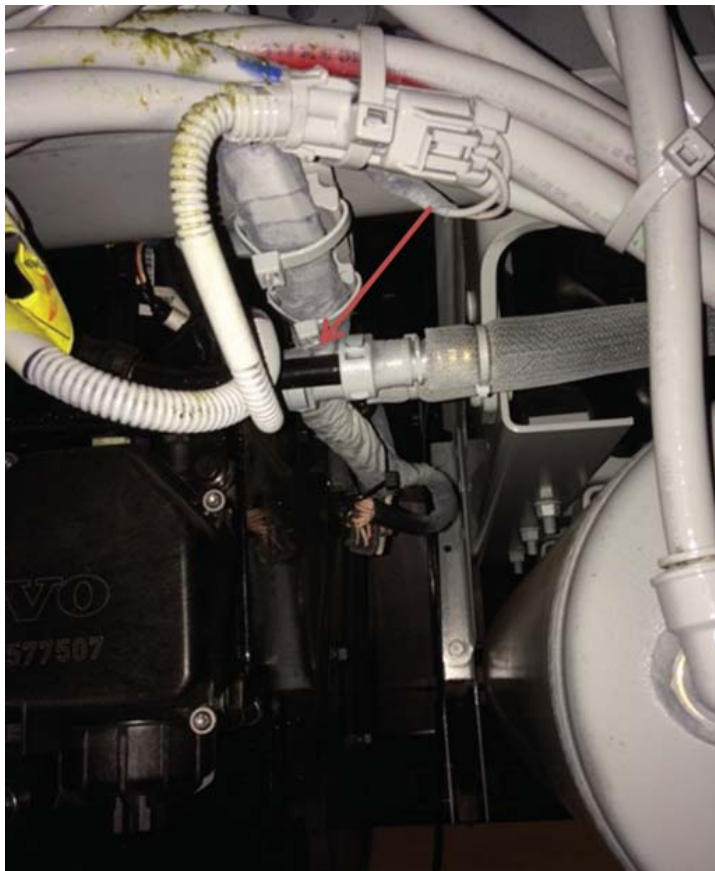
Check the section of the AHI harness that passes by the DEF supply and return lines:

If the harness is contacting the DEF lines, attach a separator tie between the harness and the lines to keep them apart.

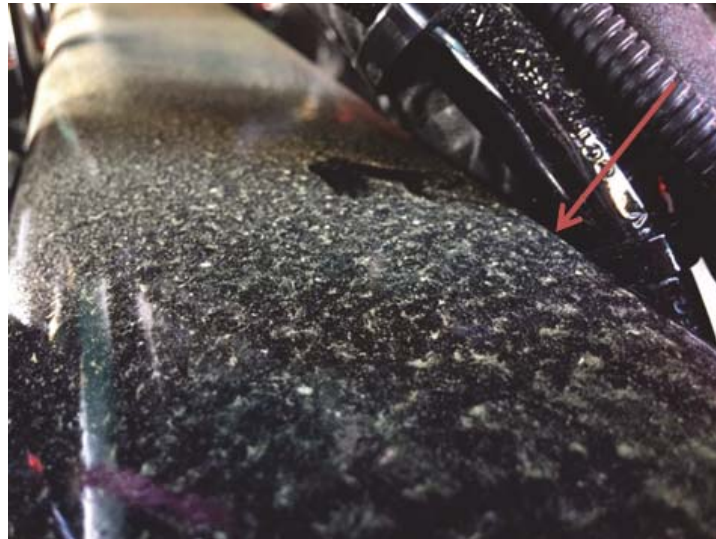
Check the area where the ACM harness passes by the frame rail:

The harness should not contact the edge of the frame rail. If there is contact with the edge, the harness needs to be properly secured to its clipping brackets so it is able to clear the rail.
