**Title (customer effect)** Service Only Regen Requested With No Warning. Diagnostic Trouble Codes ( DTC ) P24A4 / P10FE Active Or Inactive With Several Counts - **OBD15 And US14+OBD16 (Non-Common Rail Fuel System) Chassis**

**Cause** OBD15 and US14+OBD16 (Commonly Year Models 2016 and 2017) Conventional Chassis that spend most of the time in stop-and-go operation may log DTCs P24A4 and P10FE, together or separately.

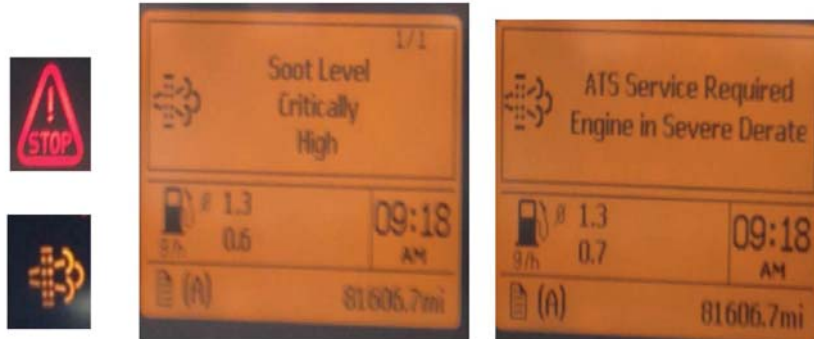
Vehicle reached "Service only" regeneration with no warning

"Service only" regeneration forces customer to visit dealership (Unplanned stop).

- Truck MY 2016/2017 (may be Truck MY 2015).
- P24A4 or P10FE fault code (>150% Soot Load), RED STOP lamp is lit
- Dealer technicians are not finding any HW problem.
- Only seen in 13L Short Haul/ City Driving vehicles
- Customers -- Parr Lumber/ Lalonde Contractors/Lansdale Warehouse etc
