SERVICE BULLETIN

Classification: EL14-056a	Reference: NTB14-120a	Date: February 27, 2018
------------------------------	--------------------------	----------------------------

2013-2018 FRONTIER AND 2013-2015 XTERRA; TRIP ODOMETER CANNOT BE RESET

APPLIED VEHICLES: 2013-2018 Frontier (D40)
2013-2015 Xterra (N50)

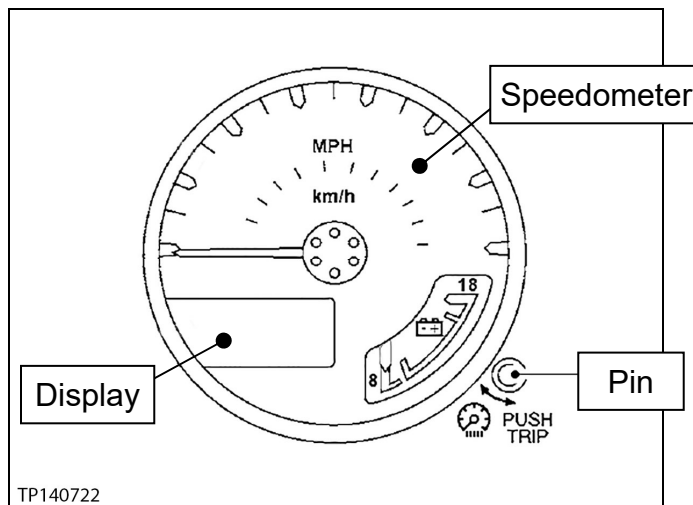
Figure 1

The reset/change button (pin) is stuck in the up or down position.

Realign the combination meter.

If rub marks are seen on the pin, replace it.
