# SERVICE BULLETIN

Classification: EL15-006o	Reference: NTB15-049o	Date: February 16, 2018
------------------------------	--------------------------	----------------------------

## TELEMATICS SERVICE INFORMATION

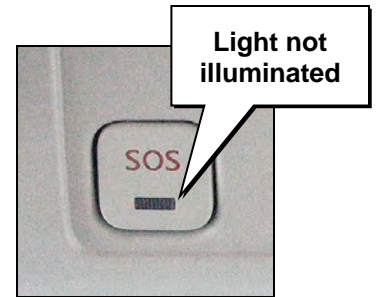
Figure 1a

1. With the vehicle in an area of known good reception, turn the ignition ON and check whether or not the green light on the SOS button is illuminated (see Figure 1a).

- If the green light **is** illuminated, the process to turn ON the TCU is complete and no further action is needed.
- If the green light **is not illuminated**, go to **Turn ON TCU** on the next page.

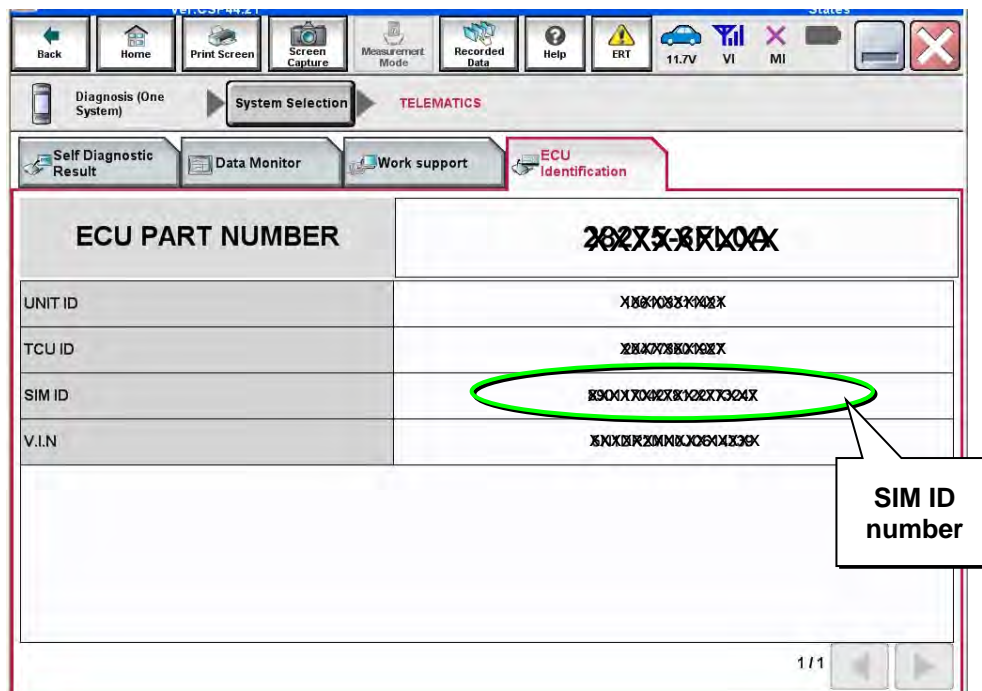
Figure 7d

a. Navigate C-III plus to the screen shown in Figure 7d.

b. Locate the SIM ID number and write it on the repair order as “Original SIM ID”.

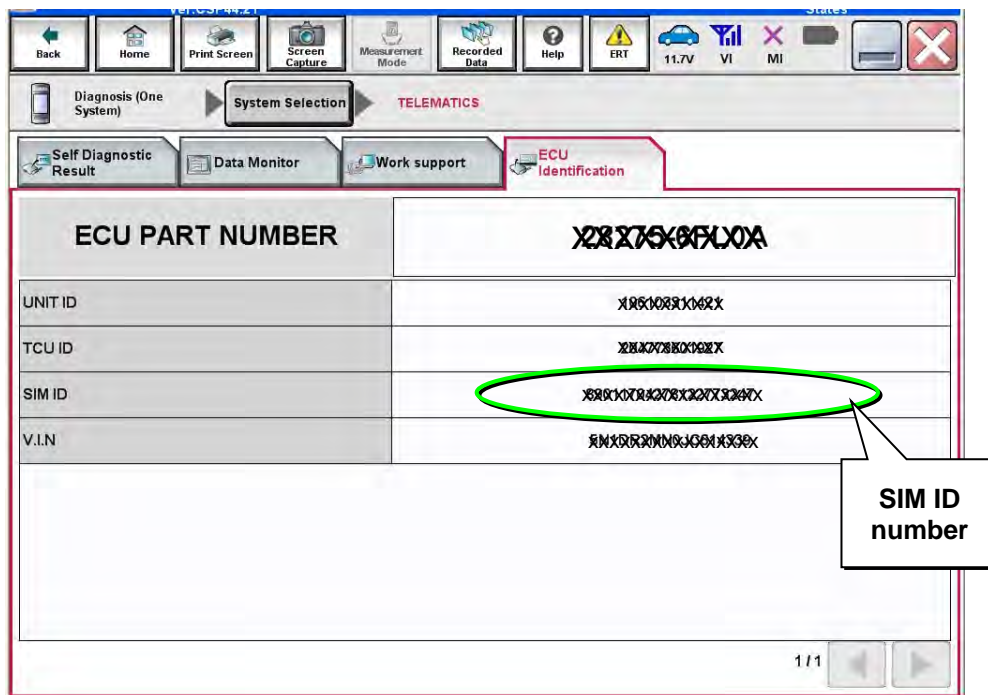
Figure 12d

\* For Rogue Sport and Armada vehicles, Manual TCU Configuration is needed only if the TCU ID number (see Figure 12d) begins with “2047”.

a. Navigate C-III plus to the screen shown in Figure 12d.

b. Locate the SIM ID number and write it on the repair order as “New SIM ID”.

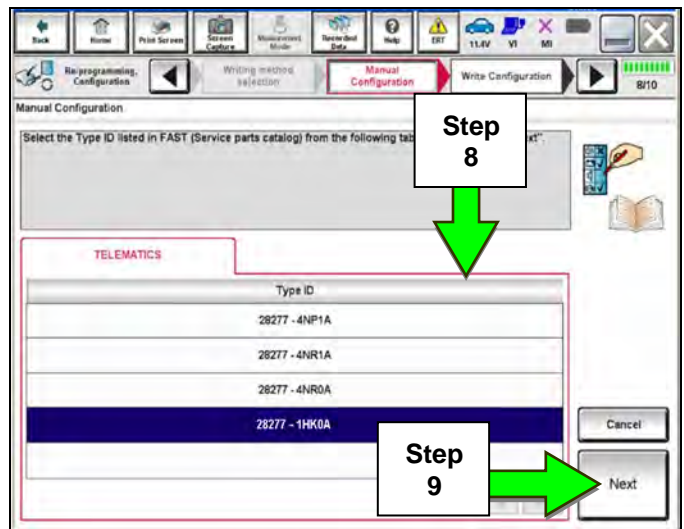
**NOTE:** If C-III plus automatically selects the Type ID, there will be no options shown under Type ID and Figure 5f will not display. Skip to step 10.
