# Service Bulletin

## PRELIMINARY INFORMATION

**Subject:** Malfunction Indicator Lamp (MIL) On, Poor Acceleration, Throttle Body Freezing, Multiple DTCs Set, Ice Deposits and/or Oil Deposits Present in Air inlet Duct

**Models:** 2008-2011 Buick Enclave  
2007-2011 Chevrolet Malibu  
2009-2011 Chevrolet Traverse  
2007-2011 GMC Acadia  
2007-2010 Pontiac G6  
2007-2009 Saturn AURA  
2007-2010 Saturn OUTLOOK  
Equipped with 3.6L Engine (RPOs LY7, LLT)

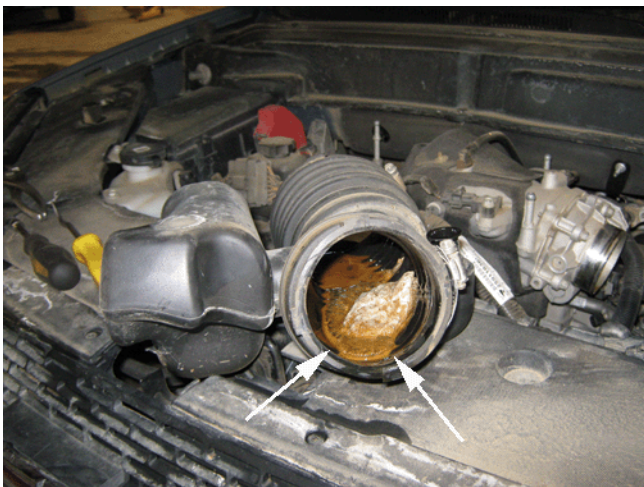
Technicians may find DTCs P0101, P0171, P0172, P0174, P0175, P1516, P2177, P2178, P2179, P2180, P2187, P2188, P2189 and/or P2190 along with either ice or oil deposits in the air inlet duct.

Ice formation is caused by condensation freezing at the base of the throttle body with additional collection of ice formation deposits in the air inlet duct. Freezing condensation forms after the vehicle has been driven and then parked in low ambient temperatures.

Oil deposits are the collection of the engine vapors, fuel dilution and oil mist at the base of the throttle body with additional formation collecting in the duct.
