SERVICE CAMPAIGN BULLETIN

NTB17-070a

VOLUNTARY SERVICE CAMPAIGN 2004-2011 TITAN, AND 2005-2011 FRONTIER AND XTERRA; AIR BAG DIAGNOSIS SENSOR UNIT

CAMPAIGN ID #: P7318

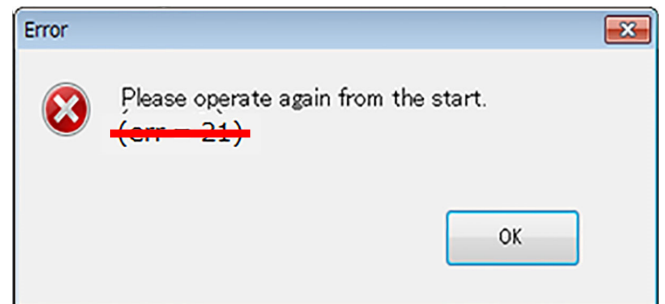
Figure 14

The reprogram procedure will need to be restarted.

After shutting down C-III plus, disconnect and reconnect the blue cable at both ends, and then start the reprogramming procedure (page 3).

Verify vehicle and C-III plus battery voltages are sufficient with the battery charger and AC adaptor connected.

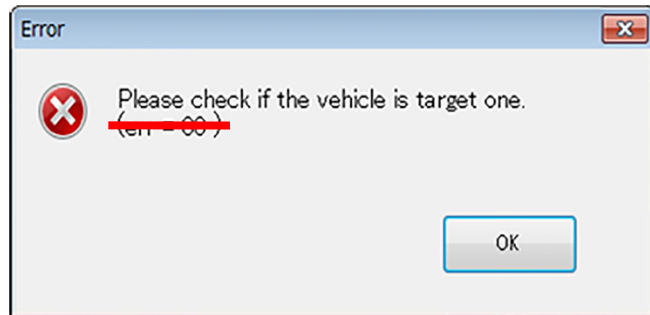
Figure 15

The air bag diagnosis sensor unit cannot be reprogrammed because the vehicle is not part of the service campaign.

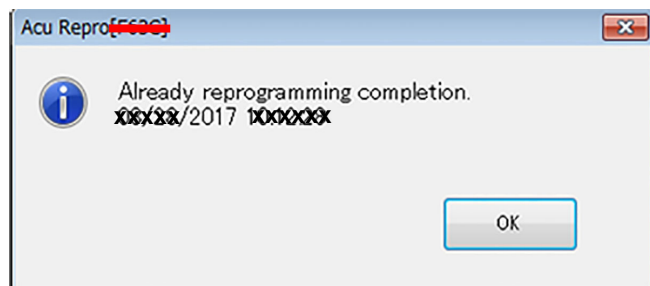
Figure 17

The vehicle's air bag diagnosis sensor unit has been previously reprogrammed.
