# Shudder on Deceleration After a Cold Soak

## Applicability

YEAR(S)	MODEL(S)	ADDITIONAL INFORMATION
2012 – 2014	Tacoma	Transmission(s): 4AT

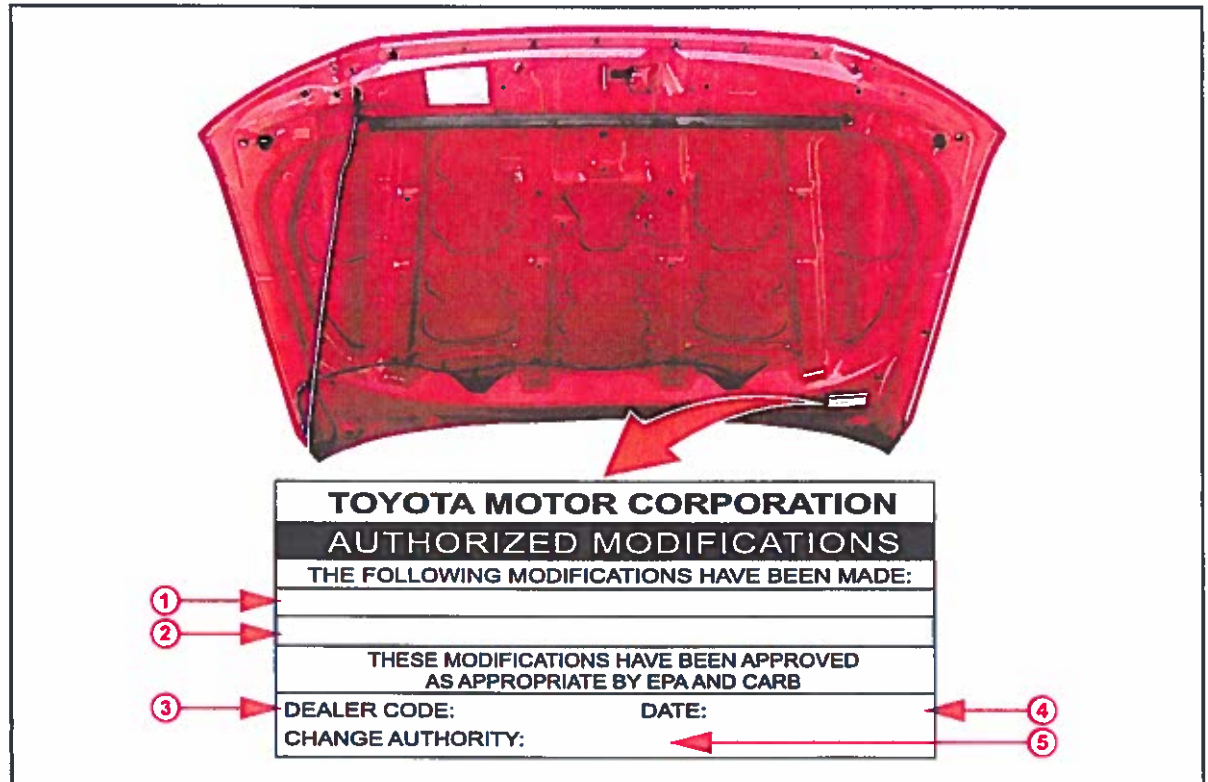
**Figure 1. Location of Authorized Modifications Label on 2012 - 2014 Tacoma**

3. Check for the Authorized Modifications Label affixed to the vehicle in the location shown in Figure 1. Confirm if the ECM (PCM) calibration has been updated. If the calibration ID listed is NOT the latest ECM (PCM) calibration — go to step 4.

<b>1</b>	Replacement ECM (PCM) Part Number (i.e., 89661-04F81)
<b>2</b>	New Calibration ID(s) (i.e., 30471100)
<b>3</b>	Dealer Code

<b>4</b>	Date Completed
<b>5</b>	This SB Number

6. Test drive and confirm the repair.
7. Install the Authorized Modifications Label.
  - A. Using a permanent marker, enter the following information on the label:
    - ECM part number [*Refer to the Parts Information section for the NEW PART NUMBER*]
    - Calibration ID(s) [*Refer to the Calibration Information section for the NEW CALIBRATION ID*]
    - Dealer Code
    - Repair Date
    - Change Authority [*This bulletin number*]
  - B. Affix the Authorized Modifications Label to the vehicle at the location shown in Figure 1. The Authorized Modifications Label is available through the MDC, P/N 00451-00001-LBL.
