Headlamp Assembly Appearance Concern

YEAR(S)	MODEL(S)	ADDITIONAL INFORMATION
2005 – 2011	Tacoma

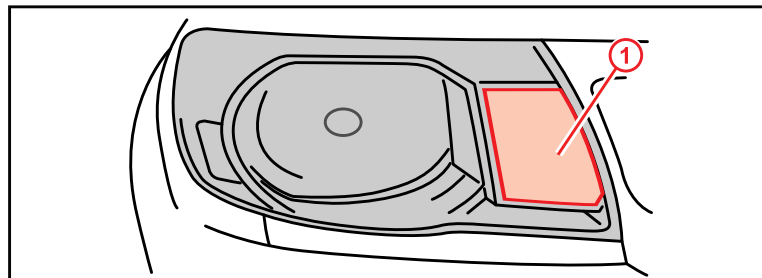
Figure 1.

Some 2005 – 2011 model year Tacoma vehicles may experience a condition where the inner Daytime Running Light (DRL)/turn signal lens becomes distorted and bubbled in appearance. In addition, the inner lens may appear cracked or separated. Updated Headlamp Assemblies have been developed to address this condition. The updated Headlamp Assemblies have cosmetic changes, so it is recommended to replace both the left and right assemblies together.

1	Appearance Concern Area in DRL/Turn Signal Lens
----------	-------------------------------------------------

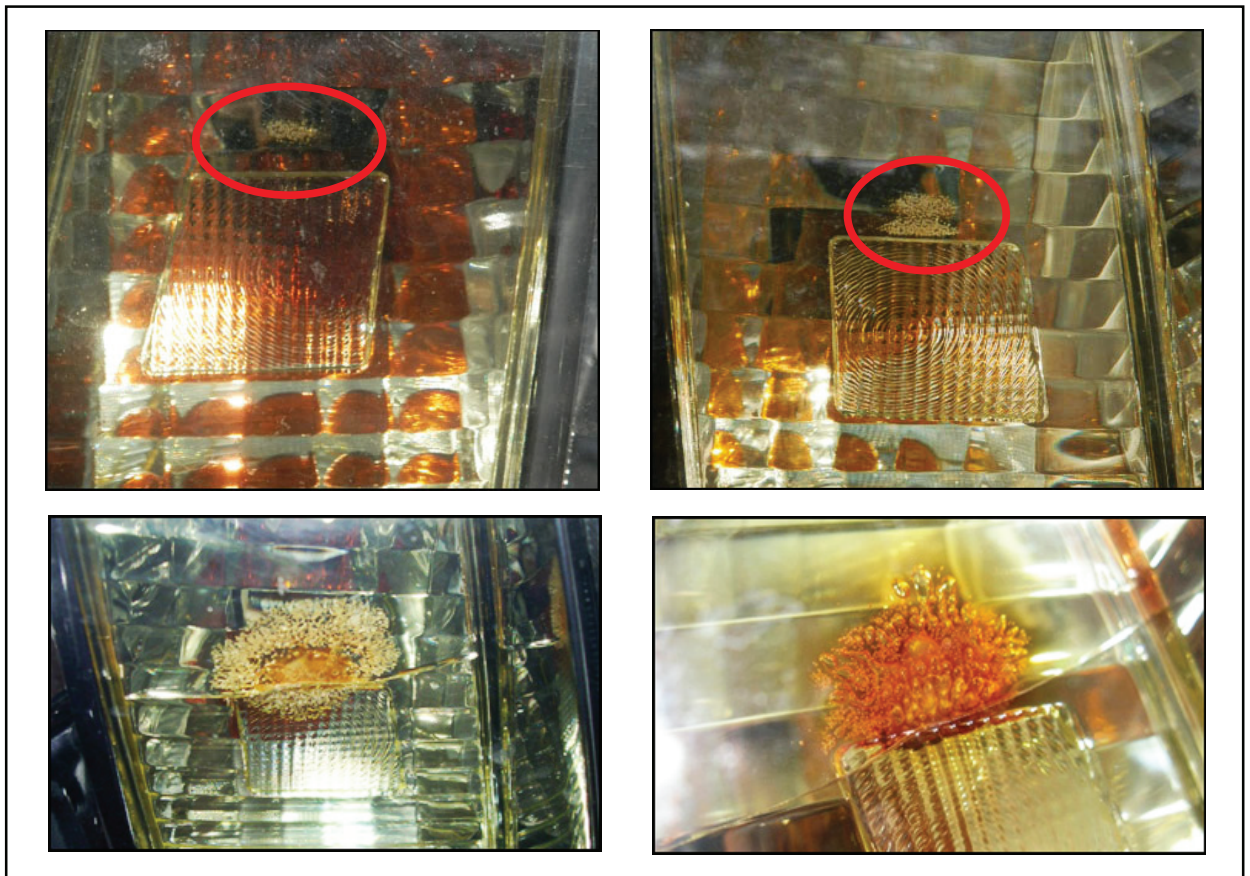
1. Determine if the inner DRL/turn signal lens portion of the Headlamp Assembly has cracked, bubbled, deformed, or distorted appearance.

Figure 2. Headlamp Inner DRL/Turn Signal Lenses Requiring Replacement

3. Replace headlamps.

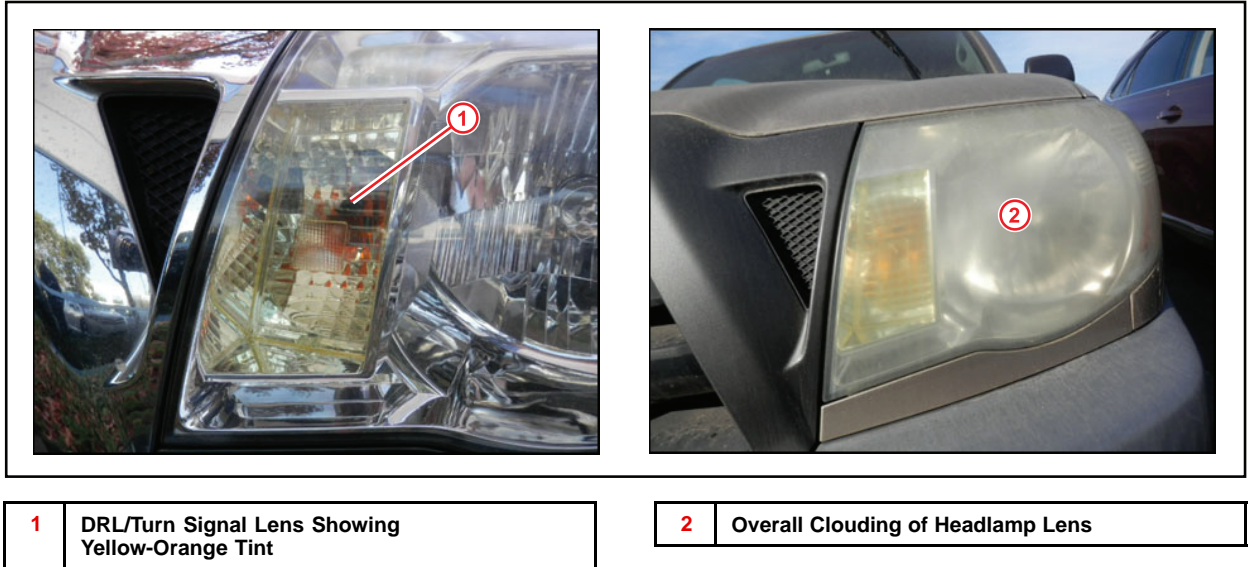
Figure 3. Headlamp Inner DRL/Turn Signal Lenses and/or Headlamp Lens Conditions NOT COVERED in this Service Bulletin

As the inner lens ages it will change from clear to yellow-orange color. If the lenses are a yellow-orange color, NO repair is necessary.
