Vibration at Idle in Park

Service Category Engine/Hybrid System

YEAR(S)	MODEL(S)	ADDITIONAL INFORMATION
2015 - 2017	NX200T

Some 2015 – 2017 model year NX 200t vehicles equipped with 8AR-FTS engines may exhibit an abnormal vibration at idle in Park. The Engine Control Module/ECM (SAE Term: Powertrain Control Module/PCM) logic has been modified to reduce the possibility of this condition occurring. Follow the Repair Procedure in this bulletin to address this condition.

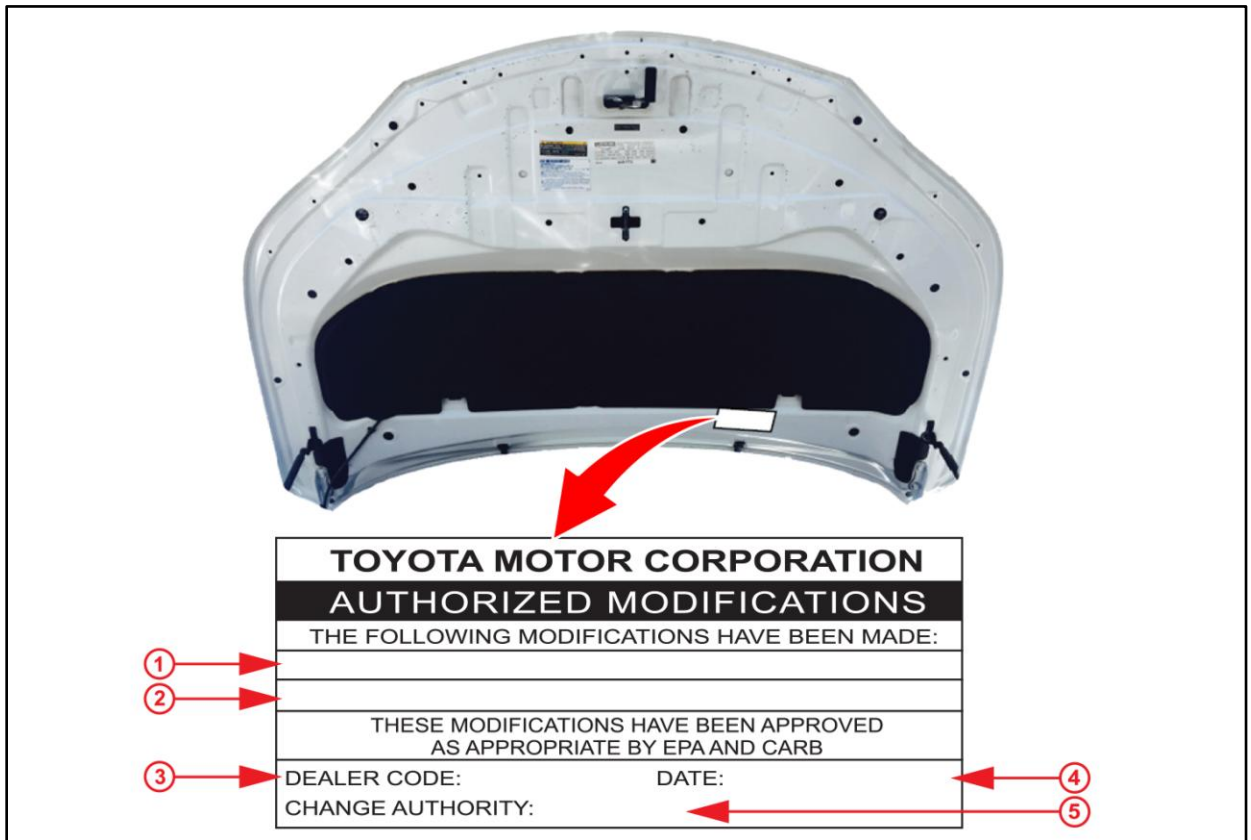
Figure 1. Location of Authorized Modifications Label on 2015 – 2017 NX 200t

- Check for the Authorized Modifications Label affixed to the vehicle in the location shown below. Confirm if the ECM (PCM) calibration has been updated.

- Prepare and install the Authorized Modifications Label.
 - Using a permanent marker, enter the following information on the label:
 - ECM part number [Refer to the **Parts Information** section for the **NEW PART NUMBER**]
 - Calibration ID(s) [Refer to the **Calibration Information** section for the **NEW CALIBRATION ID**]
 - Dealer Code
 - Repair Date
 - Change Authority [**This bulletin number**]
 - Install the Authorized Modifications Label to the vehicle at the location shown in Figure 1. The Authorized Modifications Label is available through the MDC, P/N 00451-00001-LBL.
- Verify the vibration condition is no longer present.
