Drive Shaft/Propeller Shaft

Some 2005 – 2014 model year Tacoma vehicles equipped with automatic transmission may exhibit a vibration felt in the seat, floorboard, and steering wheel between 15 – 25 mph caused by a second order drivetrain vibration under acceleration. The following Repair Procedure may improve this condition.

### **Driveline Vibration**

T-SB-0008-14

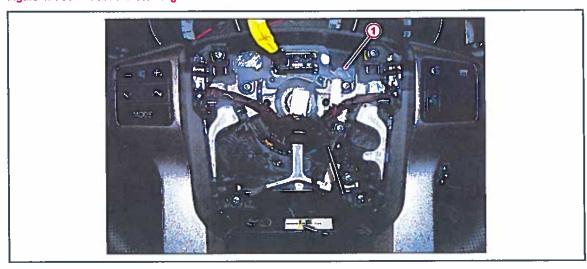
Figure 4. 2012 - 2014 MY Steering Wheel

Is the steering wheel switch wire harness retainer bracket present? (See Figure 4.)

Steering Wheel Switch Wire Harness Retainer Bracket

B. Remove the steering wheel switch wire harness retainer bracket (only for vehicles with steering wheel mounted switches).

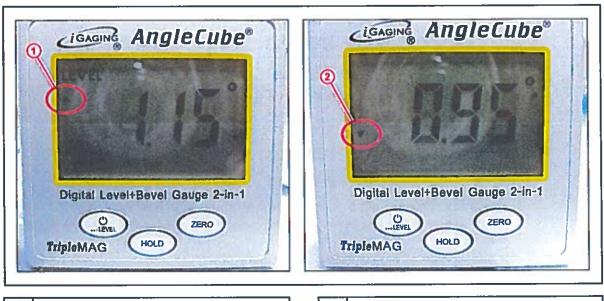
Figure 7.

All measurements must be taken from the passenger side of vehicle facing the driver side. Refer to Figure 7 below to ensure that the angles measured have the correct positive (+) or negative (-) values assigned.

- Arrow pointing up indicates a positive angle. In the example on the left, the angle measured is a positive 1.15 (+1.15).
- Arrow pointing down indicates a negative angle. In the example on the right, the angle measured is a negative 0.95 (-0.95).
