Service

Category Engine/Hybrid System

YEAR(S)	MODEL(S)	ADDITIONAL INFORMATION	
2012 – 2014	RAV4 EV

The RAV4 EV Power Management Control ECU and EV Gateway Control ECU software has been updated to improve charging performance. To ensure the best ownership experience, it is important to confirm the software is the most current version available. Use the following procedure to reprogram the RAV4 EV Power Management Control ECU and EV Gateway Control ECU.

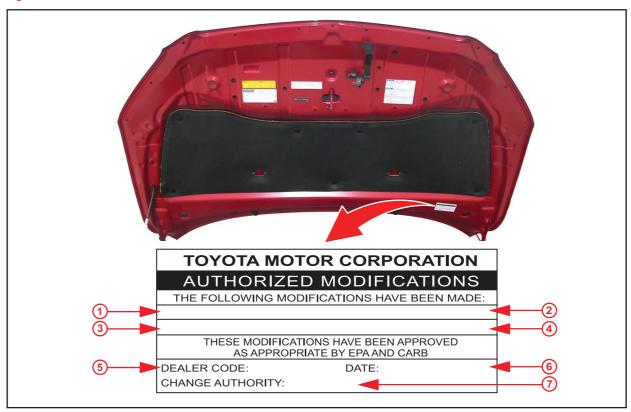
Figure 1. Location of Authorized Modifications Label on 2012 – 2014 RAV4 EV

1	Replacement Power Management Control ECU Part Number (i.e., 89690-42015)
2	Replacement EV Gateway Control ECU Part Number (i.e., 89881-0R011)
3	New Calibration ID of Power Management Control ECU (i.e., 896B34201500)
4	New Calibration ID of EV Gateway Control ECU (i.e., 1.3.83)

5	Dealer Code
6	Date Completed
7	This SB Number

1. Check for the Authorized Modifications Label affixed to the vehicle in the location shown in Figure 1. Confirm if the ECU calibrations have been updated. If the calibration IDs listed are NOT the latest ECU calibrations — go to step 2.

- 4. Install the Authorized Modifications Label.
 - A. Using a permanent marker, enter the following information on the label:
 - ECU part number(s) [Refer to the Parts Information section for the NEW PART NUMBER]
 - Calibration ID(s) [Refer to the Calibration Information section for the NEW CALIBRATION ID]
 - Dealer Code
 - Repair Date
 - Change Authority [This SB number]
 - B. Affix the Authorized Modifications Label to the vehicle at the location shown in Figure 1. The Authorized Modifications Label is available through the MDC, P/N 00451-00001-LBL.
- 5. Test drive the vehicle to confirm proper vehicle operation.

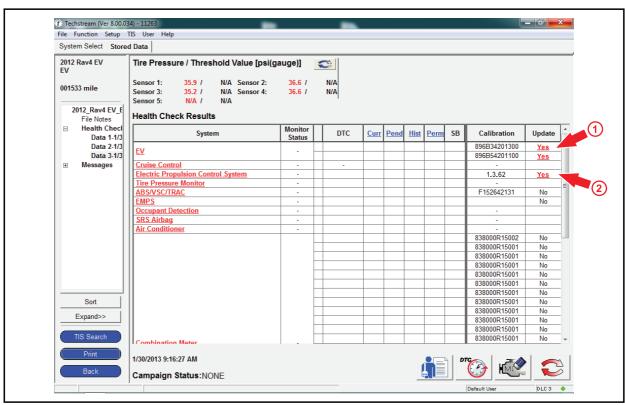
Figure 2.

1 Reprogram Power Management Control ECU 1st

2 Reprogram EV Gateway Control ECU 2nd

The Power Management Control ECU <u>must</u> be updated first, then the EV Gateway Control ECU (see Figure 2).
