Service

Category Vehicle Exterior

Section Exterior Panels/Trim Market USA

YEAR(S)	MODEL(S)	ADDITIONAL INFORMATION
2005 – 2010	tC	Plant Code(s): 0 WMI(s): JTK

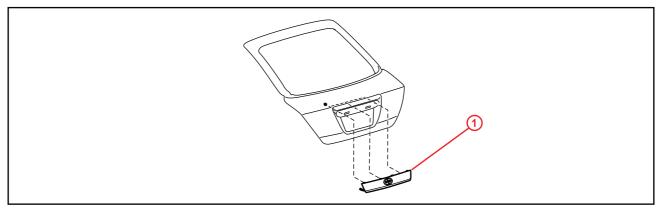
Figure 1.

Some 2005 – 2010 model year tC vehicles may exhibit a condition where the back door garnish becomes loose, and in some cases continued usage of the loose garnish may result in breakage. Please follow the procedure contained in this bulletin, which supplements the Repair Manual, to replace the back door garnish if it is loose or broken.

1 Back Door Garnish Sub-assembly Outside
