Upper Windshield Tick Noise

Service Category Vehicle Exterior

Section Window/Glass

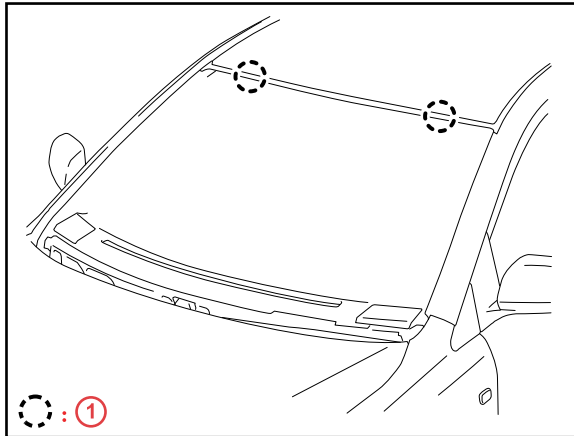
Figure 1.

If a creak, tick, or rattle noise is heard at the top of the windshield, the source of the noise may be the two windshield stoppers bonded to the top of the windshield. This bulletin provides the recommended repair procedure to eliminate these types of noises from the windshield area.

1 Stopper Locations

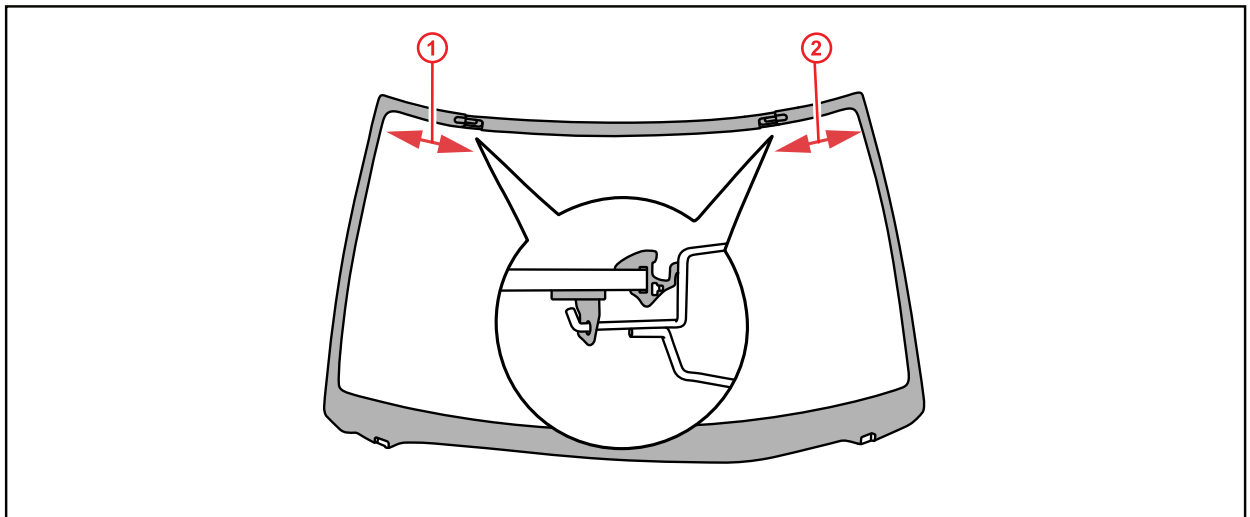
Figure 3.

The stoppers are located on the inside of the passenger compartment behind the windshield glass blackout section (near the top front edge of the metal roof opening). The stoppers are typically located 200 – 250 mm (7.9 – 9.8 in.) inboard of the top corners of the windshield glass.

1. Refer to the appropriate model year Repair Manual for the proper procedure to obtain access to the windshield stoppers.
