# Entune/Navigation Software Update Process for Display Audio (Non-HDD Type)

**Market** USA

The information contained in this bulletin supersedes SB No. T-SB-0026-12.

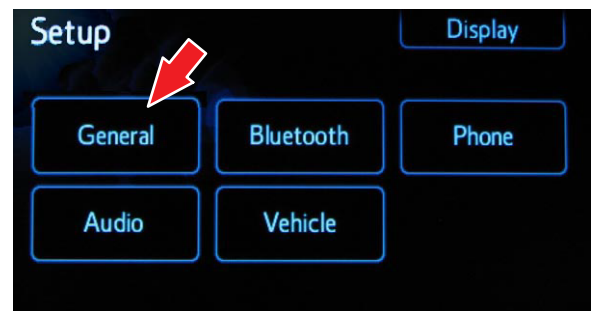
Figure 1.

1. Press the *Setup* button.
2. In the *Setup* menu, select *General*.

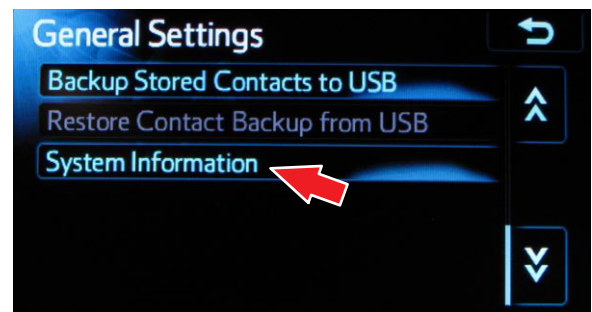
Figure 2.

3. In the *General Settings* menu, scroll down and select *System Information*.

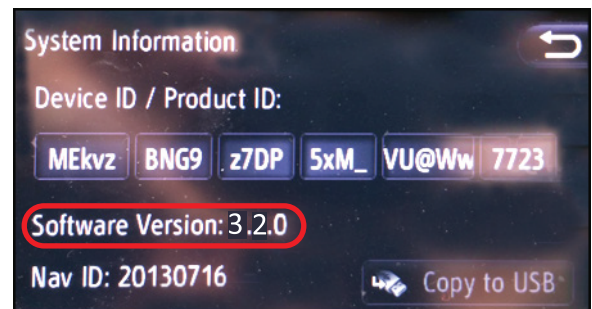
Figure 3.

4. In the *System Information* menu the Software Version information is displayed (eg., 1.7.x, 1.8.4, 2.1.0, 2.2.0, 3.1.0, 3.2.0).

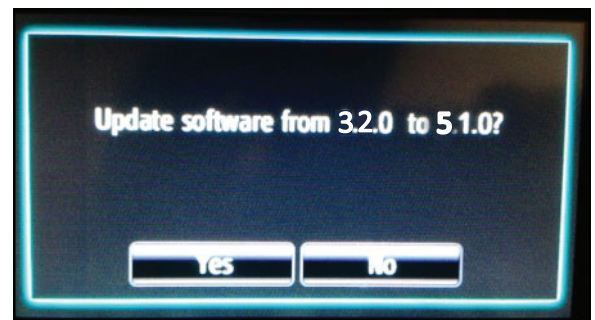
Figure 4.

1. Start the vehicle or put hybrid system in Ready ON mode.
2. Turn on the radio.
3. Press the *Apps* button (the system will switch to the *Apps* main page).
4. Install USB Drive SST into vehicle's USB slot (there will be a short pause while the software version is read).
5. An "Update software from X.X.X to 5.1.0?" message will be displayed.

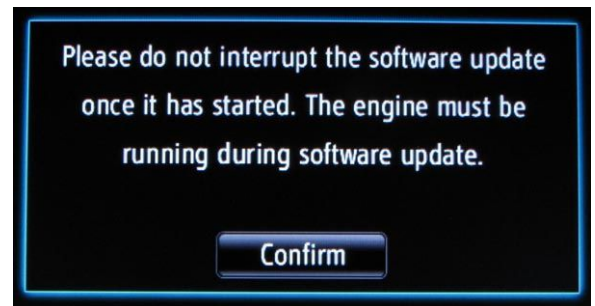
Figure 5.

6. Select Yes.
7. A "Please do not interrupt the software update once it has started. The engine must be running during software update." message will be displayed.

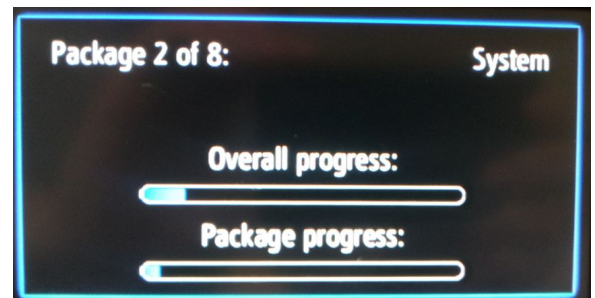
Figure 6.

8. Select *Confirm* (the engine must be running or hybrid system in Ready ON mode during software update).
9. The Software update will begin and the screen will show a "Package 1 of 8" message, and continue through 8 of 8. It will take approximately 5 minutes for the update to complete.

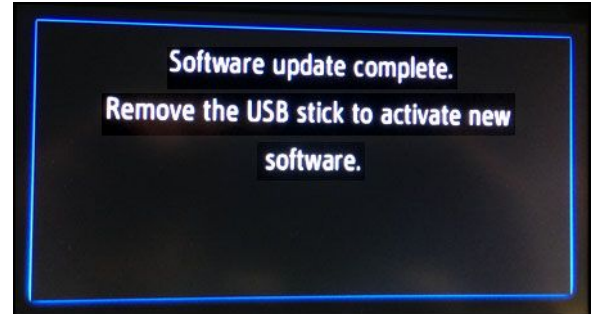
Figure 7.

10. When finished, a "Software update complete" message is displayed.

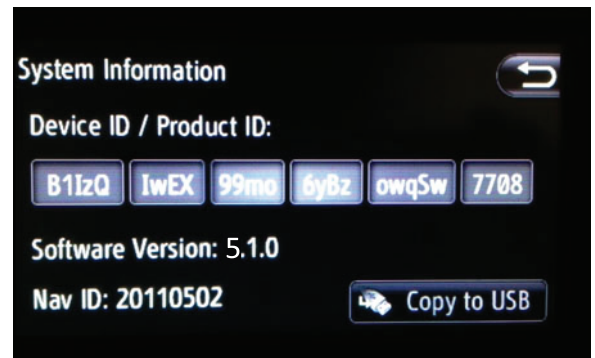
Figure 8.

11. Remove the USB Drive SST.
12. Turn the vehicle off then restart it.
13. Confirm the software version was updated by performing the Software Version Check Procedure.
