# Shudder on Deceleration After a Cold Soak

## Applicability

YEAR(S)	MODEL(S)	ADDITIONAL INFORMATION
2012 – 2014	Tacoma	Transmission(s): 4AT

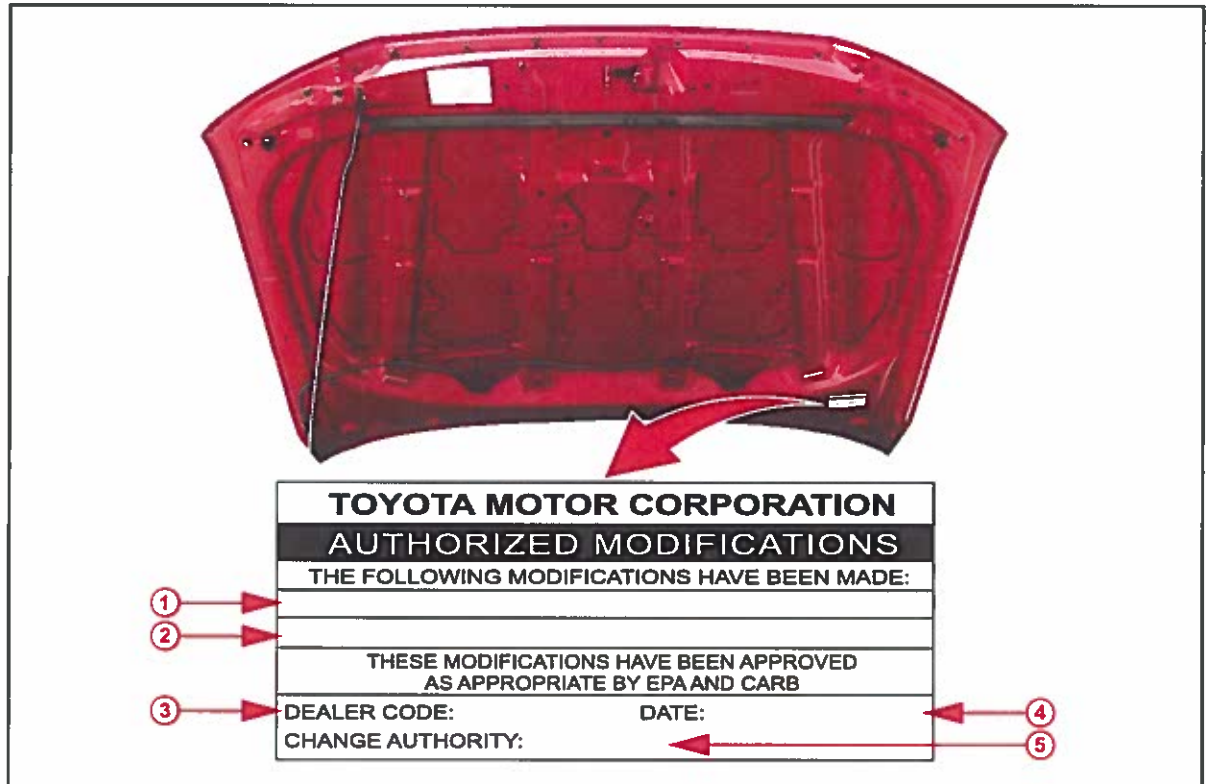
**Figure 1. Location of Authorized Modifications Label on 2012 - 2014 Tacoma**

3. Check for the Authorized Modifications Label affixed to the vehicle in the location shown in Figure 1. Confirm if the ECM (PCM) calibration has been updated. If the calibration ID listed is NOT the latest ECM (PCM) calibration — go to step 4.

1	Replacement ECM (PCM) Part Number (i.e., 89661-04F81)
2	New Calibration ID(s) (i.e., 30471100)
3	Dealer Code

4	Date Completed
5	This SB Number

6. Test drive and confirm the repair.
7. Install the Authorized Modifications Label.
  - A. Using a permanent marker, enter the following information on the label:
    - ECM part number [*Refer to the **Parts Information** section for the **NEW PART NUMBER***]
    - Calibration ID(s) [*Refer to the **Calibration Information** section for the **NEW CALIBRATION ID***]
    - Dealer Code
    - Repair Date
    - Change Authority [*This bulletin number*]
  - B. Affix the Authorized Modifications Label to the vehicle at the location shown in Figure 1. The Authorized Modifications Label is available through the MDC, P/N 00451-00001-LBL.
