# Abnormal Chirp or Squeak Noise From High Pressure Fuel Pump

YEAR(S)	MODEL(S)	ADDITIONAL INFORMATION
2013 - 2016	FR-S

## Introduction

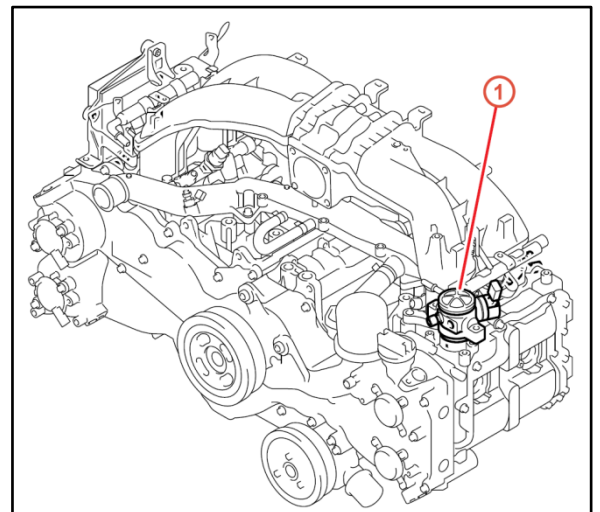
**Figure 1.**

1. Road test the vehicle for at least 10 minutes so that the engine is fully warmed-up.
2. While the engine is idling, listen for abnormal noise from the high pressure Fuel Pump Assembly.

Fuel Pump Assembly (for High Pressure)

- **YES** — Continue to step 4.
  - **NO** — This bulletin does NOT apply. Continue diagnosis using the applicable Repair Manual.
4. Replace the high pressure Fuel Pump Assembly.  
Refer to the to the Technical Information System (TIS), applicable model and model year Repair Manual:
    - 2013 FR-S:  
*Engine/Hybrid System – Fuel System – “FA20 Fuel: Fuel Pump (for High Pressure): [Removal / Installation](#)”*
    - 2014 FR-S:  
*Engine/Hybrid System – Fuel System – “FA20 Fuel: Fuel Pump (for High Pressure): [Removal / Installation](#)”*
    - 2015 FR-S:  
*Engine/Hybrid System – Fuel System – “FA20 Fuel: Fuel Pump (for High Pressure): [Removal / Installation](#)”*
    - 2016 FR-S:  
*Engine/Hybrid System – Fuel System – “FA20 Fuel: Fuel Pump (for High Pressure): [Removal / Installation](#)”*
  5. Confirm repair.
