Door Trim Rattle During Audio Playback

Service Category Vehicle Exterior

YEAR(S)	MODEL(S)	ADDITIONAL INFORMATION
2013 - 2016	Avalon, Avalon HV

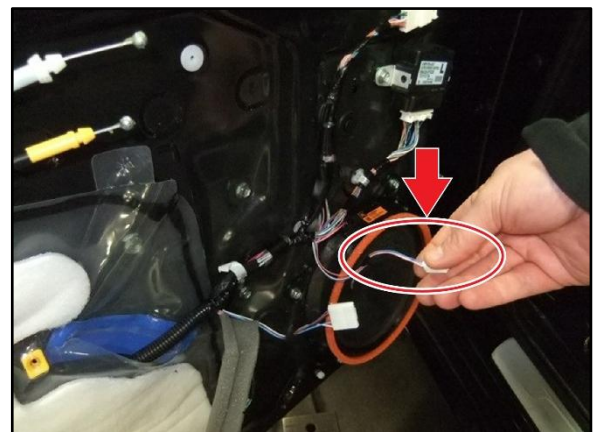
Figure 1.

Some 2013 – 2016 model year Avalon and Avalon HV vehicles may exhibit a rattle noise from the base of the left front door trim during audio playback. Follow the procedure in this bulletin to address this condition.

1. Is the rattle heard from the left front door panel?
 - **YES** – Continue to step 2.
 - **NO** – This bulletin does NOT apply. Continue diagnosis using the applicable Repair Manual.
2. Remove the left front door panel.
 Refer to the Technical Information System (TIS), applicable model and model year Repair Manual:
 - [2013](#) / [2014](#) / [2015](#) / [2016](#) Avalon:
Vehicle Exterior – Door/Hatch – “Door/Hatch: Front Door: Disassembly”
 - [2013](#) / [2014](#) / [2015](#) / [2016](#) Avalon HV:
Vehicle Exterior – Door/Hatch – “Door/Hatch: Front Door: Disassembly”
3. Disconnect the seat memory harness connector.

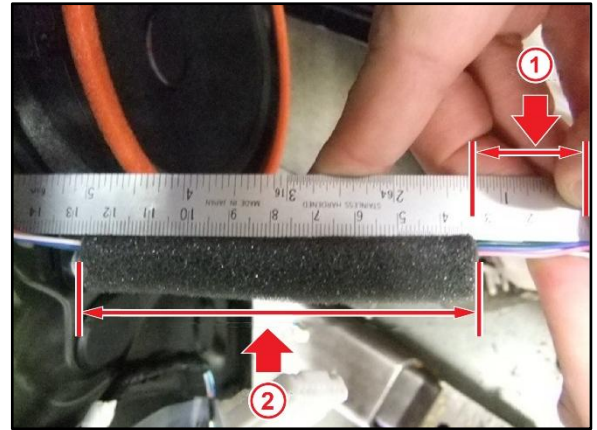
Figure 2.

1	35 mm
2	90 mm

4. Apply a 90 mm long adhesive backed foam to the seat memory wiring harness beginning 35 mm from the rear edge of the connector. Foam is available in Anti-Rattle Kit PN-08231-00801.
