Service

Category Drivetrain

Section Automatic Transmission/Transaxle

Introduction

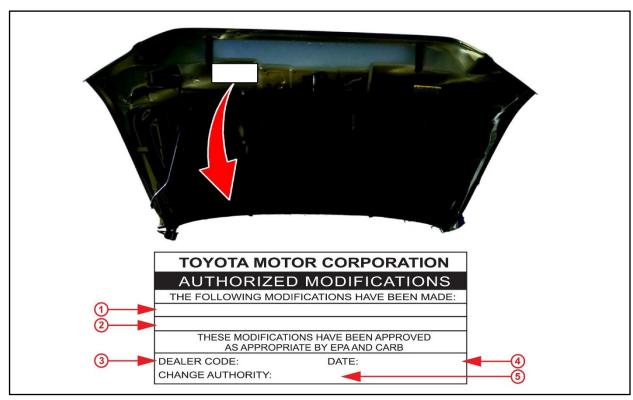
Figure 1. Location of Authorized Modifications Label on 2016 - 2017 Tacoma

2. Check for the Authorized Modifications Label affixed to the vehicle in the location shown below. Confirm if the ECM (PCM) calibration has been updated.

1	Replacement ECM (PCM) Part Number (i.e,. 89661-04K53)	
2	New Calibration ID(s) (i.e., 8966304B0300)	
3	Dealer Code

4	Date Completed	
5	This SB Number
