From: [Phil](#) [REDACTED]
To: [Kayla](#) [REDACTED]
Cc: [Richard](#) [REDACTED]
Subject: FW: Autocar with possible loose air transfer clamps
Date: Thursday, March 29, 2018 12:41:09 PM
Attachments: [image004.png](#)

From: Gena [REDACTED]
Sent: Wednesday, March 28, 2018 2:23 PM
To: Joshua [REDACTED] <joshua.[REDACTED]@cummins.com>
Cc: Phil [REDACTED] <phil.[REDACTED]@cummins.com>; Kimberly [REDACTED] <kimberly.[REDACTED]@cummins.com>; Richard [REDACTED] <richard.[REDACTED]@cummins.com>
Subject: Autocar with possible loose air transfer clamps

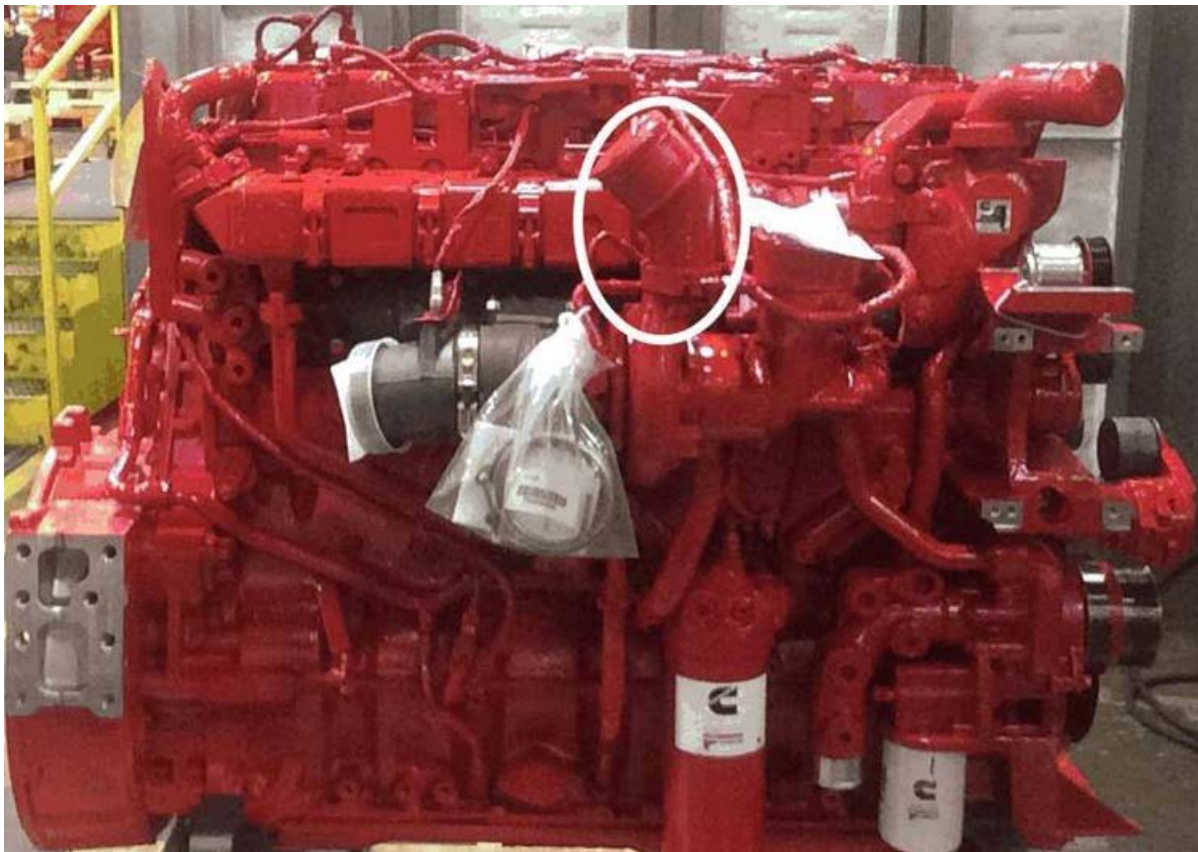
Here is a photo of the suspect inlet and clamp for reference...

Issue: There ~~could be a gap~~ **is no gap** in the trunnion area of the v-band clamp indicating the clamp is not meeting its intended function.

Possible fail mode: Loose air transfer pipe/air leak.

Fix: Ensure that the clamp is torqued to 75 in. lbs and report any defective clamps with ESN's to JEP CQA.

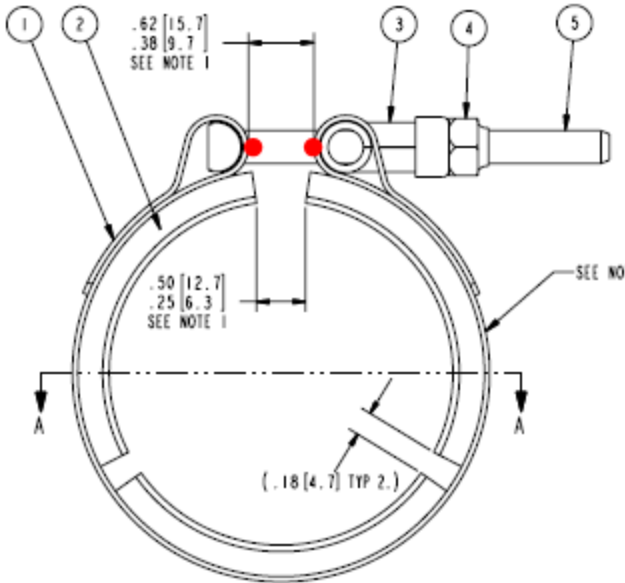
In addition, if the tech can check to see if the two trunnions are touching together (red areas in print below), this likely means a bad clamp and it will need to be replaced.

If a gap like shown below, it should be good...but it still wouldn't be a bad idea for the tech to check it.
