# Service Bulletin

**Subject:** Information for Identifying Non-GM ECM Calibration Use and Power-Up Hardware Detection in Duramax™ Diesel Engines — Photograph Tech 2® Calibration IDs, Calibration Verification Numbers (CVNs) and Transmission Data Screen

**Models:** 2006-2013 Chevrolet Express, Kodiak, Silverado  
2006-2013 GMC Savana, Sierra, TopKick  
Equipped With Duramax™ Turbocharged Diesel Engine RPO LB7, LBZ, LLY, LML, LMM, or LGH

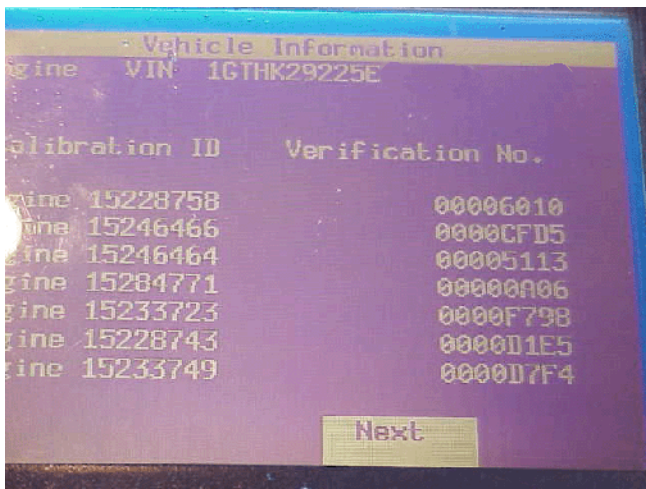
### Vehicle Information Screen

18. Take clear digital picture(s) of the Tech 2® Vehicle Information screen(s) showing the complete VIN, the Calibration IDs and the Verification Numbers. Retain the printout information and the Tech 2® screen photographs with the repair order.

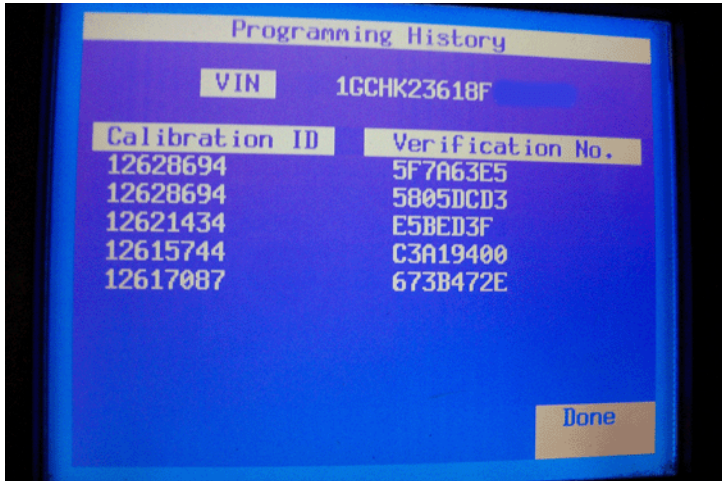
### Programming History Screen

9. Take a clear digital picture of the Tech 2® Programming History screen showing the complete VIN, Calibration IDs and the CVNs. Retain the printout information and the Tech 2® screen photograph with the repair order.

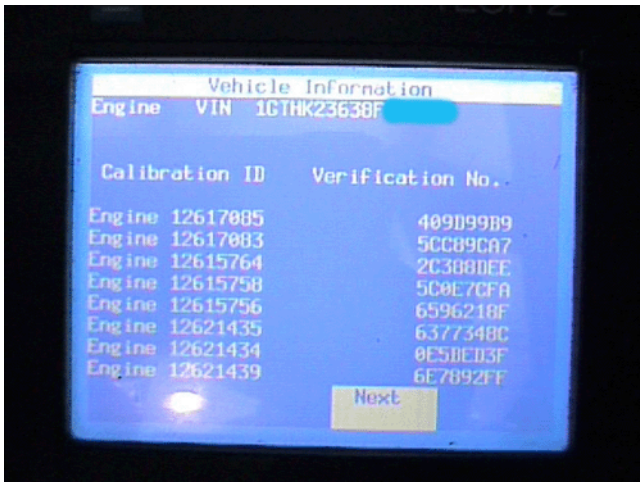
### Vehicle Information Screen

- 9.1. Take a clear digital picture of the Tech 2® Vehicle Information screen. Retain the printout information and the Tech 2® screen photograph with the repair order.
- 9.2. Take a clear digital picture of the Transmission Data screen that contains the Max Transmission Calc Engine Torque parameter. The path table is outlined in the following **Instructions for Tech 2 Transmission Data Path** section. Retain the Tech 2® Transmission Data screen photograph with the repair order.
- 9.3. E-mail copies of the digital pictures to **TACCVN@gmexpert.com** — In the **subject** line of the E-mail include the phrase "Duramax™ diesel", the complete VIN and Service Agent BAC. In the **body** of the E-mail include the complete VIN, mileage, R.O. number and Service Agent BAC. Include a brief description of the customer concern and cause of the concern.

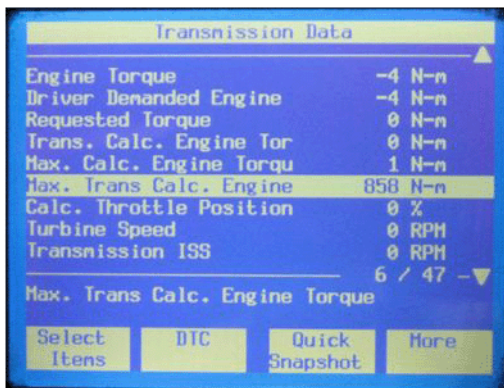
### Transmission Data Screen (Max. Transmission Calc. Engine Torque Parameter)

6. Take a clear digital picture in the .jpg file format of the Tech 2® screen showing the Transmission Data and the Max. Transmission Calc. Engine Torque parameter.
7. Retain the Tech 2® Transmission Data screen photograph with the repair order.
