HYUNDAI Technical Service Bulletin	GROUP CAMPAIGN	NUMBER 18-01-002-1
	DATE MARCH, 2018	MODEL(S) SONATA HYBRID (LF HEV) SONATA PLUG-IN HYBRID (LF PHEV)
SUBJECT: 2017 SONATA HYBRID/PLUG-IN HYBRID NAVIGATION SOFTWARE UPDATE (SERVICE CAMPAIGN T2S)

This bulletin supersedes TSB 18-01-002 to include the Caution and Warning text box on the front page.

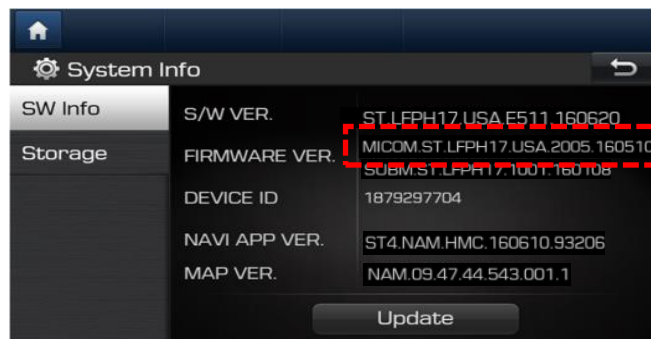
4. In the SW Info screen, check the **FIRMWARE Version:**

- Proceed with update if the OLD/Original FIRMWARE Version is the same or earlier than shown below:

- If the version is later than the OLD/Original FIRMWARE version above, then no update is needed.

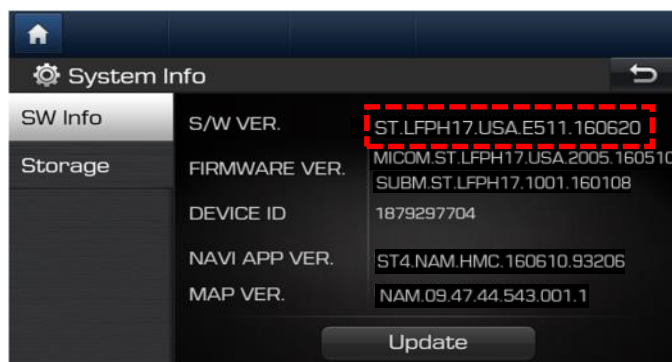
Confirm correct Update SD Card Type is used. Updating with the incorrect SD Card Type will render the head unit inoperable.

- Remove the map SD card in the slot (D) and insert the S/W Update SD Card Type using the chart in step #5.
