**** TECHNICAL INFORMATION NOTICE ****

DATE: March 9, 2018
TO: Mitsubishi Motors US & Puerto Rico Dealer Service and Parts Managers
RE: Driver's Power Seat Adjuster Assembly
TIN NO. TIN-18-52A-001

AFFECTED VEHICLES: 2016 and newer Outlander produced after 3/1/2016 (2.4L) and 3/3/2016 (3.0L)

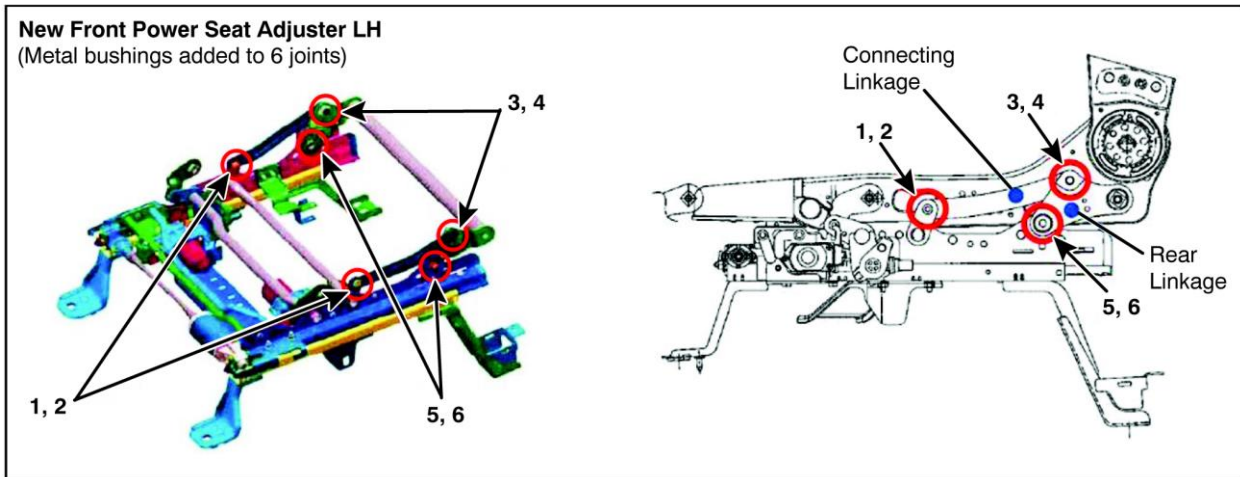
On May 2, 2017, TSB-17-52A-003 (Slight Intermittent Movement in Driver's Power Seat) was published to address customer concerns of a slight movement of the driver's power seat. The TSB instructed dealers to replace affected seat adjuster assemblies with an improved countermeasure part, part number 6922A119 (see illustration).

This concern affected Outlander vehicles built before production dates of 3/1/2016 (2.4L) and 3/3/2016 (3.0L). For vehicles built **AFTER** these production dates, it is **not recommended** to replace the driver's seat adjuster since those vehicles already have the countermeasure parts in place. However, on a case-by-case basis, contact your DPSM to review the situation further. **A DPSM PWA is required for replacement of the driver seat adjuster on affected vehicles.**
