Solution K03573329 Wednesday, April 4, 2018 10:28:39 PM CEST

Title (customer effect)	Diagnostic Trouble Codes (DTC) P2080, P2084, P242B Lighting The Malfunction Indicator Lamp (MIL) - US14+OBD13 And OBD15 Emissions (Commonly Model Years 2015 And 2016)
Cause	Diagnostic Trouble Codes (DTC) P2080, P2084, P242B can set due to incorrect calculation of " soak " time of ambient temperature after key off.

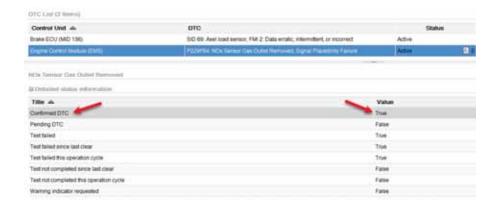
- Review the Detailed Status Information for the relevant code on the DTC Readout.

If Confirmed DTC is TRUE: Proceed with diagnostics
	• If Confirmed DTC is FALSE : Disregard and focus on other symptoms or DTCs
	relevant to the complaint.
Internal comments (BO)	No parts should be replaced for these fault codes, unless a definite sensor failure is found.
Solution visibility	Dealer distribution
Function(s)/componer	nt(s) affected
Function affected	engine , exhaust , DEF Dosing , CV electronic control unit , 110EMS , 210ACM , EECU , Diagnostic tool
Function Group	
Function Group	$254\ catalytic\ converter;$ exhaust emission control equipment , $258\ emissions$ after-treatment
Customer effect	
Main customer effect	regeneration, temperature, calibration/programming/pairing/missing operation, diagn ostics/methodology, efficiency/abnormal behavior, fault code/display
Fluid implicated	AdBlue
Temperature	does not rise in temperature
Lights/Messages on information display	other, Engine equipment fault warning pictogram, message on display,,/
