Technical Service Bulletin

34 Vibrations or rattling noises when pulling away in forward or reverse

34 18 32 2045108/2 February 26, 2018. Supersedes Technical Service Bulletin Group 34 number 16-19 dated September 26, 2016 for reasons listed below.

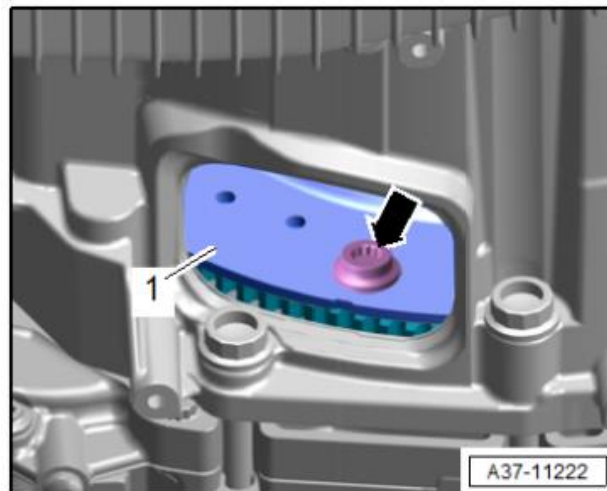
Figure 8. Flywheel bolt.

Dual-mass flywheel installed with tension on drive plate.

5. After rotating the crankshaft 360° tighten the flywheel to the drive plate following the directions in the next steps carefully.
6. Remove the transport protection tool - T40169- and install the first bolt -arrow- (Figure 8):
 - Tighten the bolt to 10 Nm
 - Loosen the bolt again
 - Tighten the bolt to 2 Nm (hand-tight)
