Technical Service Bulletin

91 MIB2: Audio is muted after using backup camera

91 18 71 2047407/2 February 1, 2018. Supersedes Technical Service Bulletin Group 91 number 17-22 dated April 7, 2017 for reasons listed below.

Model(s)	Year	VIN Range	Vehicle-Specific Equipment
A6, A7, S6, S7, and RS7	2016	All	MIB2 High Navigation

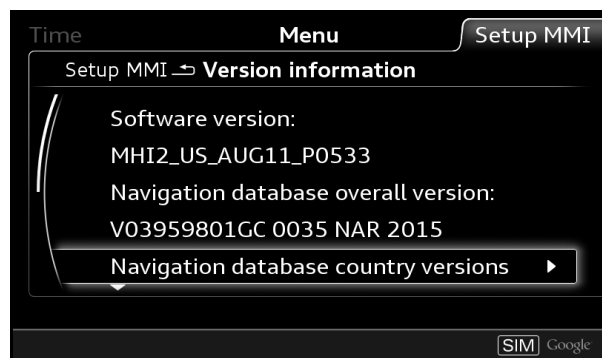
Figure 1. MMI Version Information

1. Verify the customer’s MMI requires the software update by going to the *Main Menu >> Setup MMI >> Version Information* (Figure 1).
