Technical Service Bulletin

91 SIRIUSXM intermittently no volume and message "Currently unavailable" when adjusting volume

91 18 79 2050568/1 February 27, 2018.

Model(s)	Year	VIN Range	Vehicle-Specific Equipment
A3, A4, A5, and Q5	2017	All	MIB2 High Scale

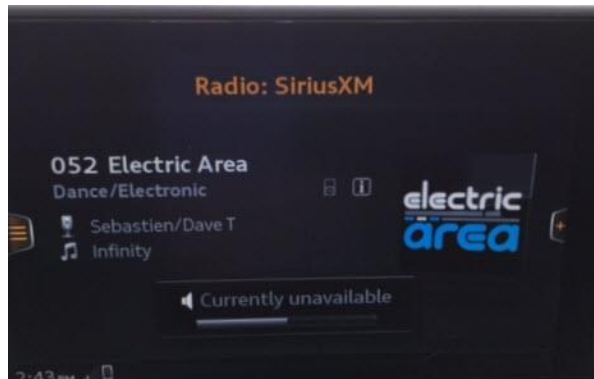
- There is no audio heard when changing the radio source to SIRIUSXM and the customer has the MIB2 High Scale infotainment system (PR Code 7UH).
- The message "Currently unavailable" is shown via the volume display.
- Only restarting the car (ignition cycle) or performing a three-finger reset fixes the concern.

Figure 1. Message "Currently unavailable"

The MIB2 High Scale infotainment system (PR Code 7UH) has a known software issue which can cause the volume to be muted when the SIRIUSXM radio source is selected. The issue can occur intermittently and is only resolved when the ignition is cycled off and back on.

Update the MIB2 High Scale infotainment system using either Method 1 or Method 2 according to TSB 2050565: *91 MIB2 High Scale Software Update Instructions (PR Code 7UH)* and use SVM code MHS2US1242AU.
