Technical Service Bulletin

01 MIL on (DTCs P200400, P200500, P200600 and/or P200700) stored in ECM

01 17 47 2048411/3 November 30, 2017. Supersedes Technical Service Bulletin Group 01 number 17-27 dated July 19, 2017 for reasons listed below.

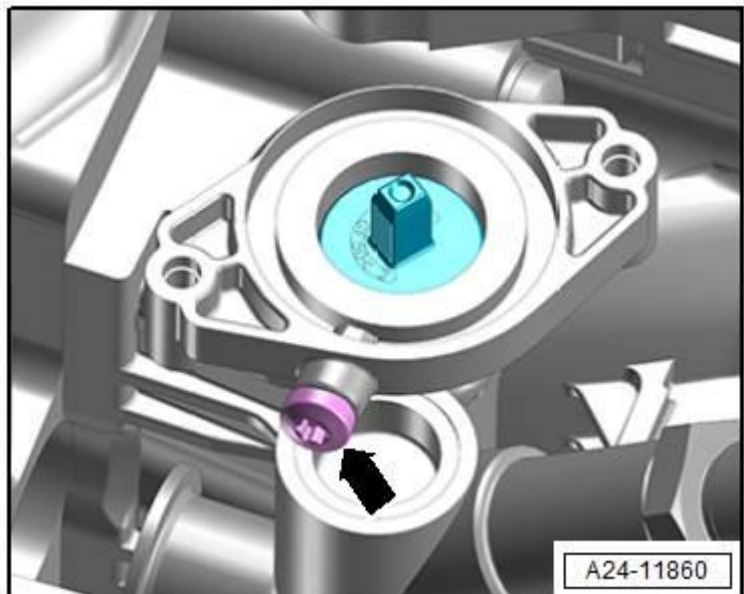
Moisture ingress into potentiometer.

Figure 1. Micro-encapsulated bolt (A24-11860 of repair manual).

If the DTC is logged due to a fault of the vacuum regulator (bank 1 or 2) or the potentiometer for the intake manifold flap adjustment (bank 1 or 2, G336 or G512) and the vacuum supply of the intake manifold flap adjustment is not the cause, fit the repair kit 079198135 on both banks. The repair kit consists of one vacuum regulator, one potentiometer, and one micro-encapsulated bolt.

When replacing the potentiometer, the micro-encapsulated bolt of the potentiometer (Figure 1) must be replaced. The micro-encapsulated bolt is included in repair kit 079198135.
