# Technical Service Bulletin

## 91 Audi connect not working due to MMI Privacy Mode at PDI MY2018

91 17 55 2048436/3 November 2, 2017. Supersedes Technical Service Bulletin Group 91 number 17-46 dated August 31, 2017 for reasons listed below.

Model(s)	Year	VIN Range	Vehicle-Specific Equipment
A3, A4, S4, A5, S5 Cabriolet, Q5, and Q7	2018	All	With MMI Navigation plus

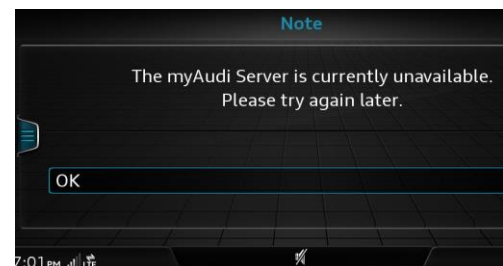
After PDI is performed, the customer states that the Audi connect services are not functioning. There is an error of “The myAudi Server is currently unavailable. Please try again later” along with an active LTE connection including data bars over the “LTE” symbol (Figure 1).

**Figure 1.** Audi connect error in MMI.

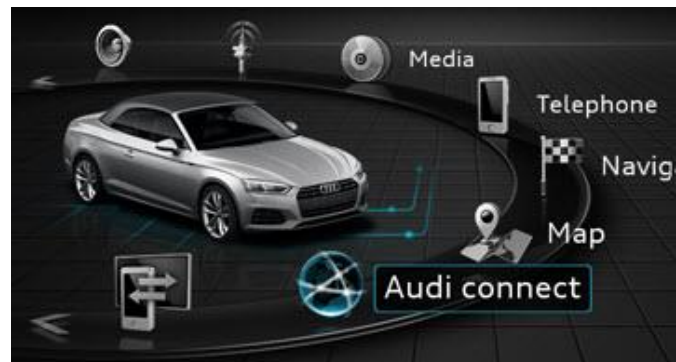
*Figure 2. Audi connect in main menu.*

1. Check the MMI in the glovebox, and if a removable SIM card is inserted then remove it. The USA market does not use removable SIM cards for MIB2 with embedded SIM. If a removable SIM card is inserted it can prevent the MMI from being able to use Audi connect services.
2. Press the "**MENU**" button and select "**Audi connect**" from the main MMI Menu (Figure 2).

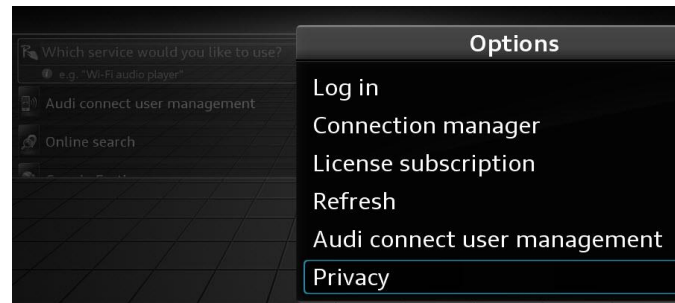
Figure 3. Right sub-men option, “Privacy”.

3. Use the Right Drawer Sub-menu (Move the Main MMI Knob to the right) and select **“Privacy”** (Figure 3).

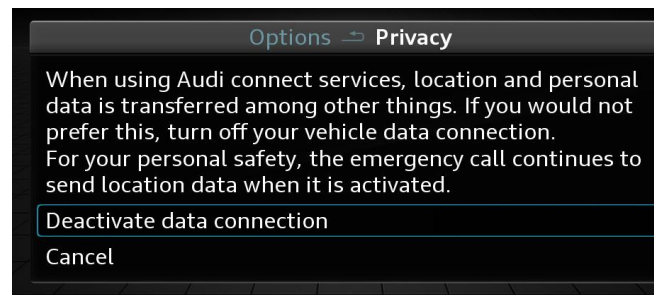
Figure 4. Deactivate data connection.

4. Next select **“Deactivate data connection”** (Figure 4).

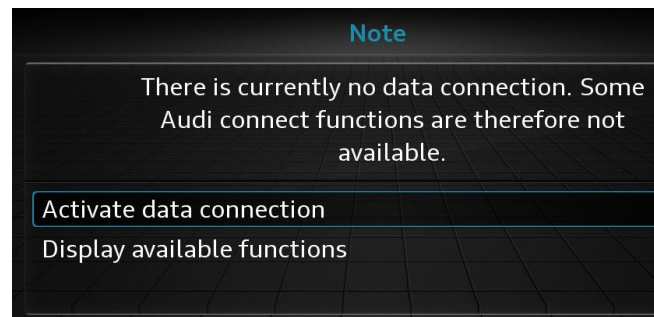
Figure 5. Activate data connection.

5. The MMI will now show a message of **“The data connection was restricted”** and the MMI should automatically revert back to the main menu.
6. Next select **“Audi connect”**, then select **“Activate data connection”** (Figure 5).

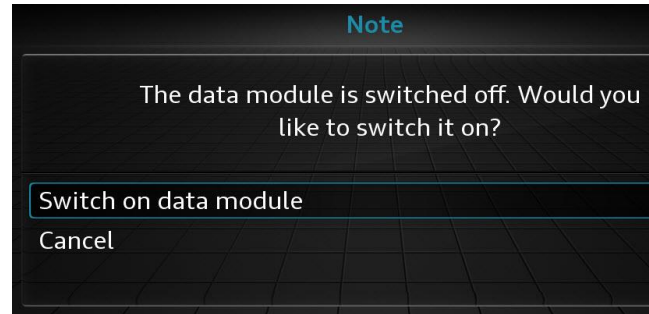
**Figure 6.** Switch on data module.

7. Next select **“Switch on data module”**. This will turn on the LTE data module (Figure 6).

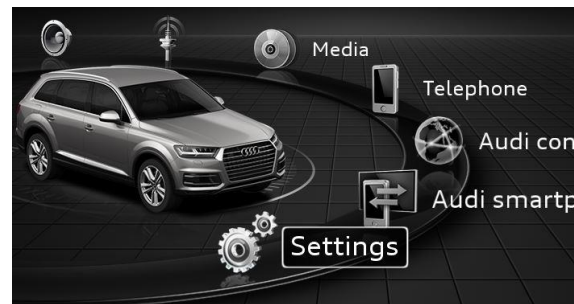
**Figure 7.** Select Settings from main menu.

12. If Audi connect still does not work then repeat steps 9-11 and let the car sit locked for 30 minutes.
13. If steps 9-11 do not work then perform a full factory reset on the MMI: Press MENU >> Settings >> Factory settings >> Select all entries >> Restore factory settings >> Yes, delete now and restart system (Figure 7-11).

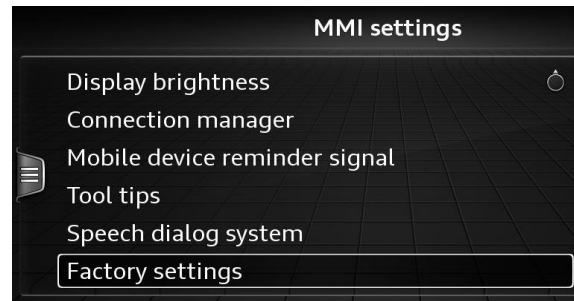
**Figure 8.** Select Factory settings.

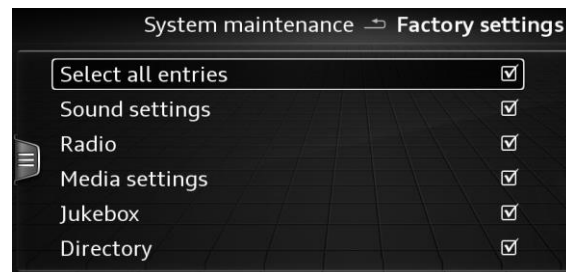
**Figure 9.** Select all entries.

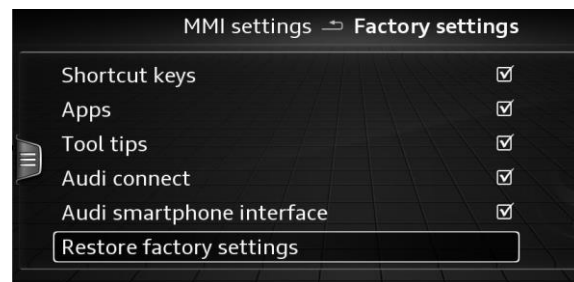
**Figure 10.** Select Restore factory settings.

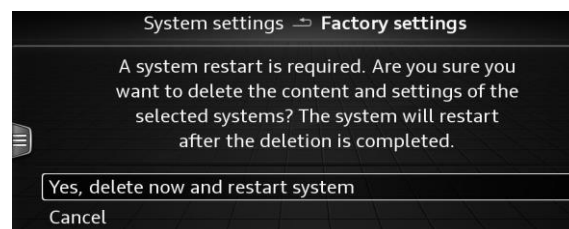
**Figure 11.** Select “Yes, delete now and restart system.”
