Emissions Recall Code: 23V5

Subject	3.0L TDI Engine – Emissions System Modification – Customer Only (Retail Sold) TDI Vehicles <u>USA ONLY</u>
Release Date	November 14, 2017
Revision Summary	Updated work procedure and added link to repair video.
Affected Vehicles	U.S.A.: 2013-2015 MY Audi Q7 3.0L TDI Generation 2.1
	Check Campaigns/Actions screen in Elsa on the day of repair to verify that a VIN qualifies for repair under this action. Elsa is the <u>only</u> valid campaign inquiry & verification source.
	✓ Campaign status must show "open."
	 If Elsa shows other open action(s), inform your customer so that the work can also be completed at the same time the vehicle is in the workshop for this campaign.
Problem Description	3.0L TDI vehicles were equipped with undisclosed Auxiliary Emission Control Devices which are not permitted by emissions regulations.
Corrective Action	Install updated engine control module (ECM) software, transmission control module (TCM) software and hardware to bring affected vehicles into regulatory compliance.

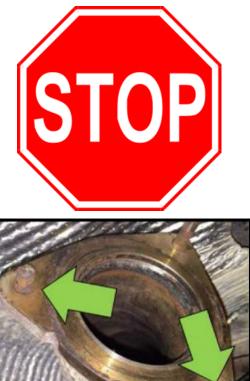
OTC 5057 Clevis Pin Press

Due to corrosion, one or more of the mounting studs may break <arrows> when removing the SCR catalytic converter from the Diesel Particulate Filter (DPF) flange.

DO NOT use a hammer and punch, heat, torch, air hammer, or other method to remove the studs from the DPF flange.

- If stud replacement is necessary, IT IS **REQUIRED** to use a press tool such as the OTC 5057 clevis pin press (or equivalent), or other available screw or hydraulic type clevis/stud press tool to remove all necessary studs from the rear DPF flange.
 - It is advised if one stud breaks that all 0 three studs are pressed out and replaced with the bolts/nuts included in the parts kit.
 - For best results, cut any studs that do not 0 break off as close to the flange as Pressing a full length stud possible. increases the chance of bending the stud, which may complicate the removal process.
 - Use a cap from the VAS 6122 Engine Bung Set (or equivalent) to cover the hole in the DPF to eliminate the chance of contaminating of the DPF substrate with metallic particles when cutting the studs.
- Install the replacement bolts and corresponding nuts into the rear DPF flange.
