46 17 03 November 21, 2017 **2015173** Supersedes Technical Bulletin 46-16-07 (V461607) dated August 23, 2016 to include model year 2018 applicability.

Brake Disc Pulsation or Vibration (U.S. Only)

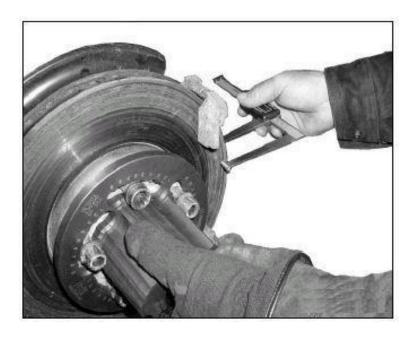
- Inspect brake disc friction surfaces on both sides of the brake disc for:
- Severe discoloration (bluing)
- High heat surface damage (raised hard spots)
- Visible cracks

Brake discs showing any of the above described conditions are **NOT** serviceable. Parts must be replaced in accordance with the Volkswagen Warranty Policy and Procedure Manual.

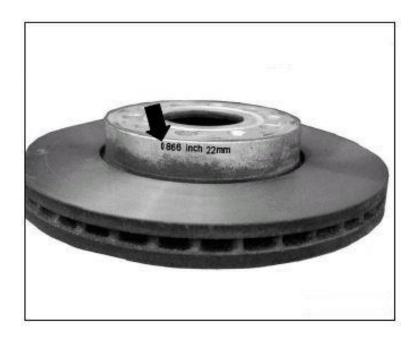
Each brake disc has the minimum allowed thickness cast, stamped or laser-etched into the disc hub.

Measure the brake disc thickness in 4 locations using either the Pro Cut International™ disc thickness
measuring tool Part No. 50-902 or the Hunter Engineering Company disc thickness measuring tool Part No. 2599-2. Measurements MUST be taken at the same distance from the brake disc outer circumference to ensure
consistency.

The brake disc thickness measurement must exceed the minimum specification after the machining process is completed in order to be re-used. If the brake disc thickness measurement does not meet this requirement, then replace the brake disc

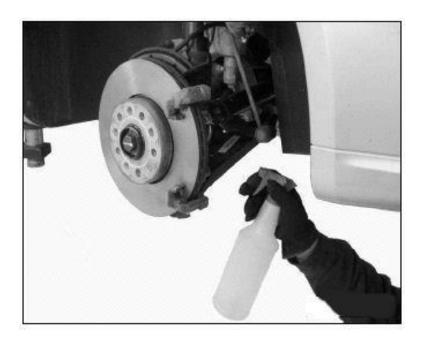
Recommended on-car brake lathes are either the PRO-CUT International ™ PFM 9.0, or the Hunter Engineering Company model OCL 400. This design of brake lathe will produce a surface quality which will provide proper brake performance without a brake pad to brake disc break-in period.

To ensure that a high quality brake disc finish is produced, brake lathe cutting tools must be maintained as directed by the lathe or tool manufacturer.

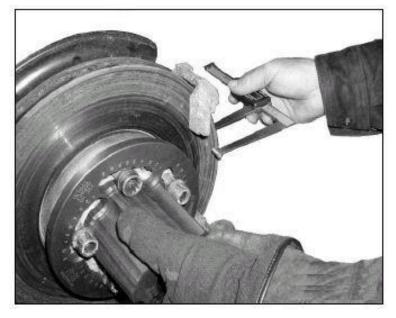
- Follow the brake lathe manufacturer's instructions for set-up and machining.
- Wash the brake disc with a soap and water solution upon completion of resurfacing to remove all machining particles.

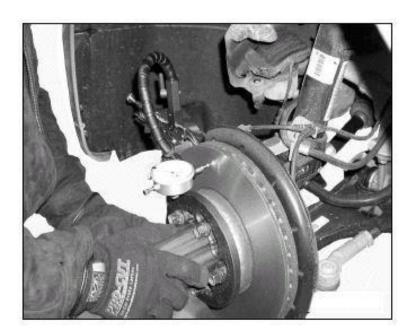
- Measure brake disc lateral run out using Pro Cut Disc Lateral run out measuring kit Part No. 50-700FC or the Hunter Disc Lateral run out measuring kit Part No. 25-128-2 with a dial indicator.
- Run out must not exceed 0.1mm.
- If brake disc exceed the 0.1mm specification replace the applicable brake discs.
