**SERVICE INFORMATION BULLETIN**

**APPLICABILITY:** All Models with Harman Audio / Infotainment      **NUMBER:** 15-220-18  
**SUBJECT:** Troubleshooting Apple CarPlay and Android Auto Connectivity Concerns      **DATE:** 03/08/18

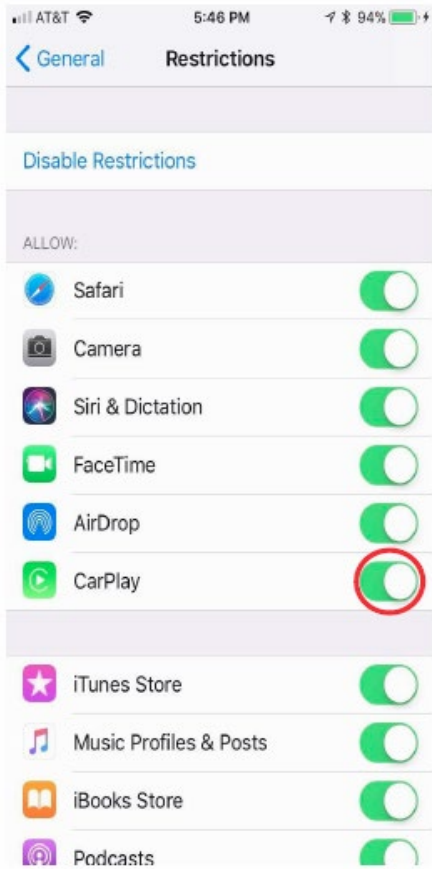
- Confirm Restrictions have been disabled by going to: **Settings > General > Restrictions**. If the slider is green as shown in the illustration below, CarPlay is NOT restricted (CarPlay is operational).
- If the slider is to the left (slider is gray), CarPlay is restricted. Either move the slider to the right (green) or press Enable Restrictions (you may be required to create / use a password to use the Enable Restrictions function).

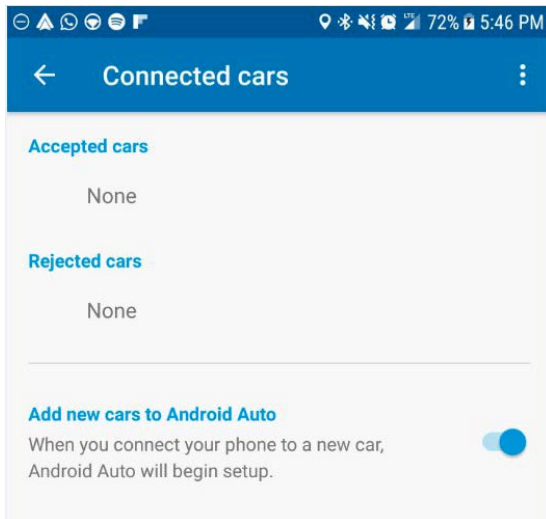
- Open **Android Auto > Open the Menu on the top left > Settings > Connected Cars**
- Enable “Add new cars to Android Auto” by moving the slider to the right as shown in the image to the left.
