Service Information Bulletin

SUBJECT	DATE
SPN 3361/FMI 5 (ACM) (GHG17) SPN 3361/FMI 5 (ACM) (GHG14)	January 2017

2 SPN 3361/FMI 5 - GHG17

3 SPN 3361/FMI 5 - GHG14

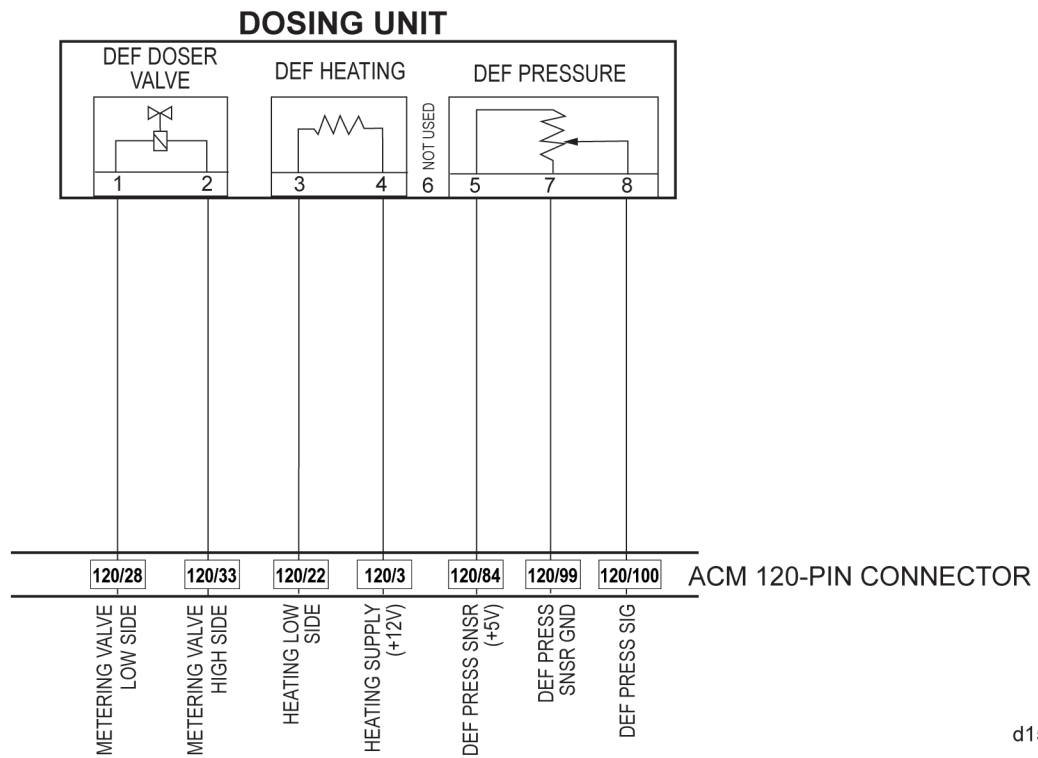
d150286b

Diesel Exhaust Fluid System Circuit Failed Open

SPN 3361/FMI 5	
Description	This Fault Code Sets When the Aftertreatment Control Module (ACM) Detects an Open in the Diesel Exhaust Fluid DEF Doser Valve Electrical Circuit
Monitored Parameter	DEF Dosing Unit Voltage
Typical Enabling Conditions	DEF Dosing Enabled Then Disabled
Monitor Sequence	None
Execution Frequency	Continuous When Enabling Conditions Met
Typical Duration	50 Seconds (max)
Dash Lamps	MIL, CEL
Engine Reaction	Derate 25%
Verification	Key OFF Five Minutes After Repair

1. Turn the ignition OFF.
2. Disconnect and inspect the DEF dosing unit electrical connector harness side. Is there corrosion present?
 - a. Yes; replace the DEF dosing unit and the aftertreatment harness. Refer to section "Removal of the Diesel Exhaust Fluid Dosing Unit". Verify repairs.
 - b. No; Go to step 3.
3. Are any of the pins or the connector damaged?
 - a. Yes; Go to step 4.
 - b. No; Go to step 5.

4. Inspect the DEF dosing unit electrical connector component side. Are any of the pins or the connector damaged?
 - a. Yes; replace the DEF dosing unit and the aftertreatment harness.
Refer to section "Removal of the Diesel Exhaust Fluid Dosing Unit"
Refer to section "Removal of the 1-BOX™ Aftertreatment Harness"
Verify repairs.

- b. No; replace the aftertreatment harness. Refer to section "Removal of the 1-BOX™ Aftertreatment Harness".
Verify repairs.
5. Use the appropriate flex probe and check pins 1 and 2 in the DEF dosing unit electrical connector harness side. Is either of the pins spread?

- a. Yes; replace the aftertreatment harness. Refer to section "Removal of the 1-BOX™ Aftertreatment Harness".
Verify repairs.
 - b. No; Go to step 6.
6. Jump pin 1 to pin 2 on the DEF dosing unit electrical connector harness side.

7. Connect DiagnosticLink®.
8. Turn the ignition ON (key ON, engine OFF).
9. Check the fault codes. Is fault code SPN 3361/FMI 5 now inactive and fault code SPN 3361/FMI 3 now active?

- a. Yes; replace the DEF dosing unit. Refer to section "Removal of the Diesel Exhaust Fluid Dosing Unit". Verify repairs.
 - b. No; replace the aftertreatment harness.

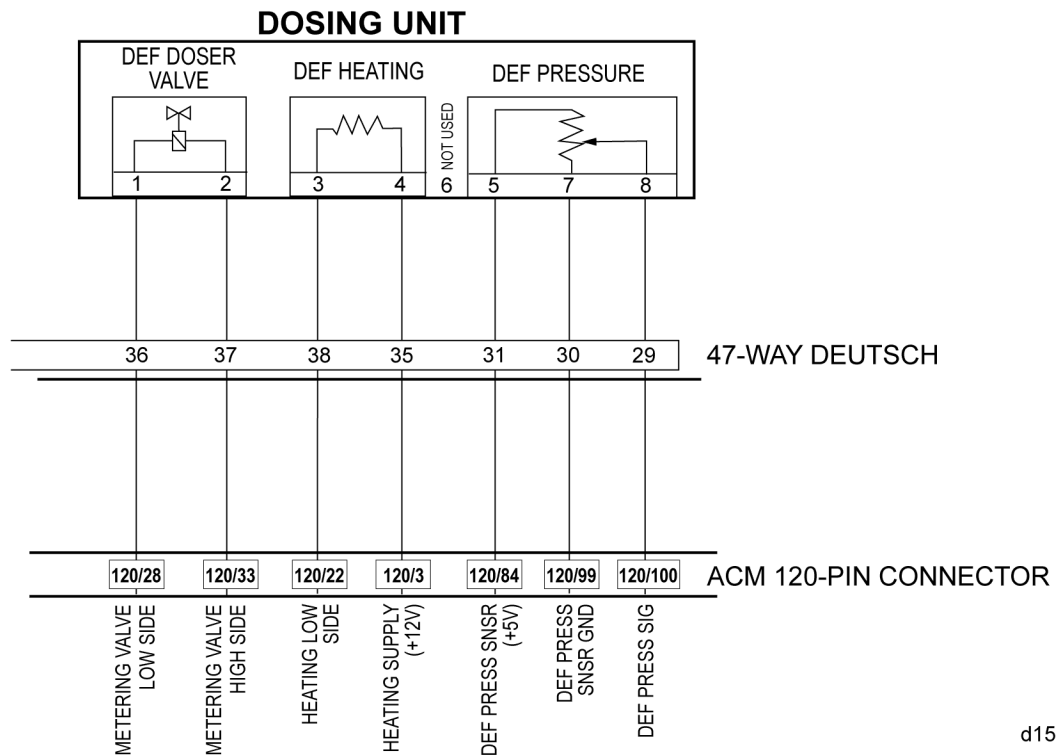
Diesel Exhaust Fluid System Circuit Failed Open

SPN 3361/FMI 5	
Description	This Fault Code Sets When the Aftertreatment Control Module (ACM) Detects an Open on the Diesel Exhaust Fluid (DEF) Doser Valve Circuit
Monitored Parameter	DEF Dosing Unit Voltage
Typical Enabling Conditions	DEF Dosing Enabled Then Disabled
Monitor Sequence	None
Execution Frequency	Continuous When Enabling Conditions Met
Typical Duration	50 Seconds (Max)
Dash Lamps	MIL, CEL
Engine Reaction	Derate 25%
Verification	Key OFF Five Minutes After Repair

1. Turn the ignition OFF.
2. Disconnect and inspect the DEF dosing unit electrical connector harness side. Is there corrosion present?
 - a. Yes; replace the harness and the DEF doser.
 - b. No; Go to step 3.
3. Are any of the pins or the connector damaged?
 - a. Yes; Go to step 4.
 - b. No; Go to step 5.
4. Inspect the DEF dosing unit electrical connector component side. Are any of the pins or the connector damaged?

- a. Yes; replace the DEF Dosing Unit and the harness on the aftertreatment system.
Refer to section "Removal of the GHG14 Dosing System Doser"
Refer to section "Removal of the 1-BOX Aftertreatment Harness"
Verify repairs.

- b. No; replace the harness on the aftertreatment system. Refer to section "Removal of the 1-BOX Aftertreatment Harness". Verify repairs.
5. Use the appropriate flex probes and check pins 1 and 2 in the DEF dosing unit electrical connector harness side. Is either of the pins spread?

- a. Yes; replace the harness on the aftertreatment system. Refer to section "Removal of the 1-BOX Aftertreatment Harness". Verify repairs.
 - b. No; Go to step 6.

6. Jump pin 1 to pin 2 on the DEF dosing unit electrical connector harness side.
 7. Connect DiagnosticLink[®].
 8. Turn the ignition ON (key ON, engine OFF).

9. Check the fault codes. Is fault code SPN 3361/FMI 5 now inactive and fault code SPN 3361/FMI 3 now active?
 - a. Yes; replace the DEF dosing unit. Refer to section "Removal of the GHG14 Dosing System Doser". Verify repairs.

- b. No; Go to step 10.
 10. Turn the ignition OFF.
 11. Disconnect and inspect the Deutsch 47-way electrical connector harness side. Is there corrosion present?

- a. Yes; replace both aftertreatment harnesses. Verify repair.
 - b. No; Go to step 12.
 12. Are any of the pins or the connector damaged?
 - a. Yes; Go to step 13.

- b. No; Go to step 14.
 13. Inspect the DEF Dosing Unit electrical connector component side. Are any of the pins or the connector damaged?
 - a. Yes; repair the aftertreatment harness on the vehicle side and replace the harness on the aftertreatment system. Refer to section "Removal of the 1-BOX Aftertreatment Harness". Verify repairs.

- b. No; replace the harness on the aftertreatment system. Refer to section "Removal of the 1-BOX Aftertreatment Harness". Verify repairs.
 14. Use the appropriate flex probe and check pins 36 and 37 in the Deutsche 47-way electrical connector, vehicle harness side. Is either of the pins spread?

- a. Yes; repair the aftertreatment harness vehicle side. Verify repairs.
 - b. No; Go to step 15.
 15. Jump pin 36 to pin 37 on the 47-way Deutsche electrical connector, vehicle harness side.

16. Turn the ignition ON (key ON, engine OFF).
 17. Check the fault codes. Is fault code SPN 3361/FMI 5 now inactive and fault code SPN 3361/FMI 3 now active?

- a. Yes; replace the harness on the aftertreatment system. Refer to section "Removal of the 1-BOX Aftertreatment Harness". Verify repairs.
 - b. No; Go to step 18.

18. Disconnect the ACM 120-pin electrical connector. Measure the resistance between pin 36 of the Deutsch 47-way electrical connector, vehicle harness side and pin 28 of the ACM 120-pin connector, harness side. Is the resistance less than five ohms?

- a. Yes; repair the open circuit between pin 37 of the Deutsche 47-way electrical connector, vehicle harness side and pin 33 of the ACM 120-pin connector. Verify repairs.

- b. No; repair the open circuit between pin 36 of the Deutsche 47-way electrical connector, vehicle harness side and pin 28 of the ACM 120-pin connector. Verify repairs.
