Service Category	Vehicle Exterior		
Section	Door/Hatch	Market USA	Toyota Supports

YEAR(S)	MODEL(S)	ADDITIONAL INFORMATION
2017 - 2018	C-HR

Some 2017 – 2018 model year C-HR vehicles may exhibit a squeak from the rear door outside handle(s). This condition may be present under hot and/or sunny conditions during door handle operation or when pressing against the handle clip location. Follow the Repair Procedure in this bulletin to address this condition.

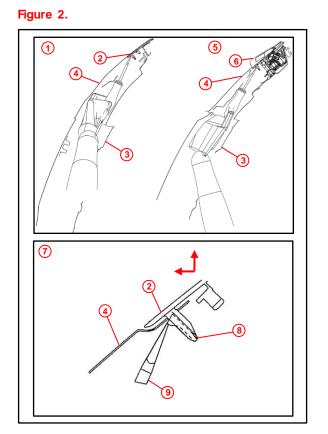
1	RR Claw Section
2	RR Door Outside Handle
3	Inner Panel
4	Outer Panel
5	FR Claw Section
6	RR Door Outside Handle
7	Claw View
8	Clip
9	Flat Head Screwdriver

3. Using the door panel access hole, disengage the outside door handle claw by gently pushing upward on the clip with a flat head screwdriver.

Do NOT pull outward on the outside handle without the claws disengaged. This can damage the door panel surface and the outside door handle, requiring repair of the door panel and/or the door handle.
