Bluetooth and Phone Menu Icons Unavailable

Service Category Audio/Visual/Telematics

YEAR(S)	MODEL(S)	ADDITIONAL INFORMATION
2013	GS350, GS450H, LX570, RX350, RX450H

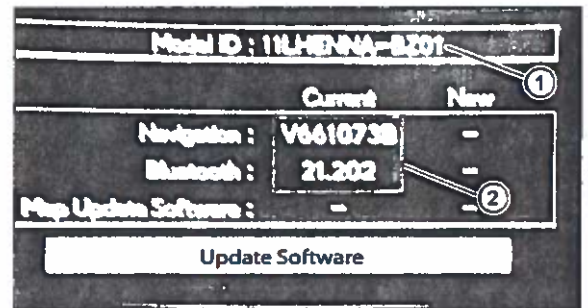
Figure 5.

1	ID Varies According to Vehicle
2	Current Version Is Displayed

7. Connect USB memory stick for the update.

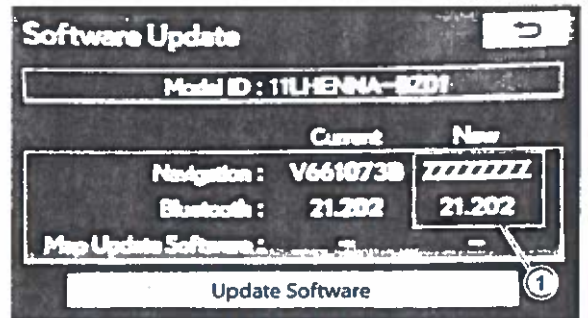
Figure 6.

1	Version to be Updated Is Displayed
---	------------------------------------

8. Press "Update Software".
