Rubbing or Grinding Noise From Rear on Turns

Service Category Brake

Section Brake (rear)

YEAR(S)	MODEL(S)	ADDITIONAL INFORMATION
2007 – 2012	Tundra

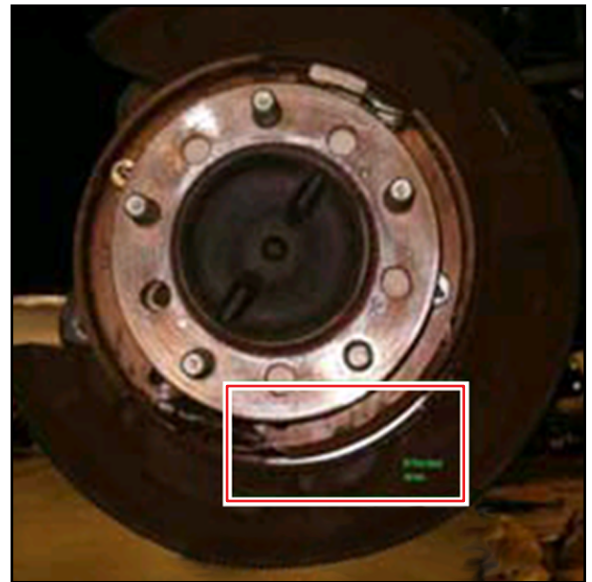
1. Test drive the vehicle and confirm the condition by making left and right hand turns.
2. Once the condition has been confirmed, place the vehicle on the lift, remove the rear wheels and rear rotors and check for any irregular contact on the brake plate from the rotors.

Figure 1. Example of Irregular Contact on Brake Plate

3. If there appears to be irregular contact from the rotor to the brake plate, replace all parts specified in the Special Service Part Bearing Kit (including the parking brake backing plate).
