Steering Column "Pop" Noise

Section Steering Column

YEAR(S)	MODEL(S)	ADDITIONAL INFORMATION
2009 – 2013	Venza

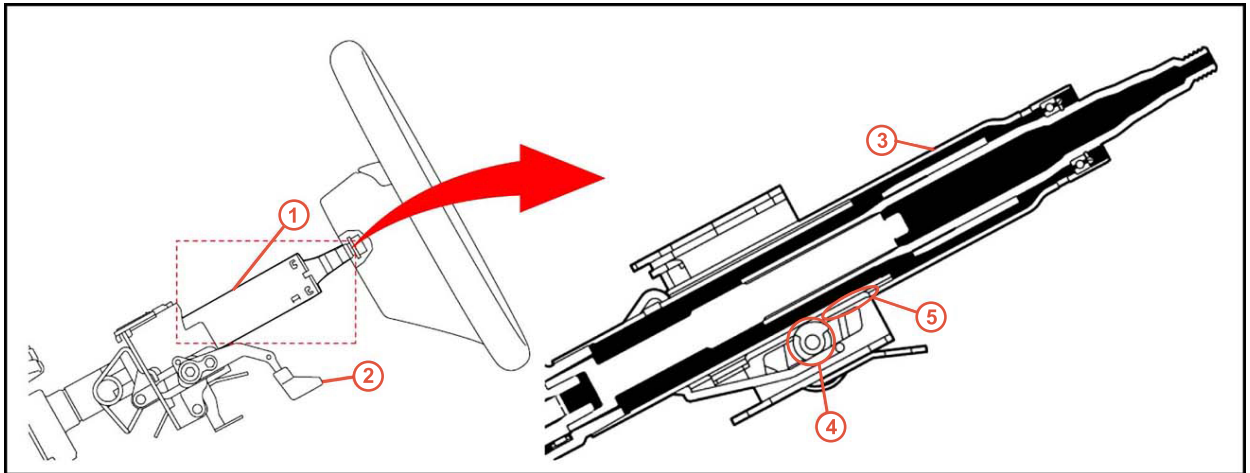
Figure 1.

Some 2009 – 2013 model year Venza vehicles may exhibit a “pop” noise from the steering column when turning the steering wheel sharply during low speed maneuvers. Perform the repair procedure outlined in this bulletin to address this condition.

With the vehicle in Park and engine running, release the column tilt/telescopic lever and rotate the steering wheel from right lock to left lock several times (refer to Figure 1).

With the tilt/telescopic lever released, did the steering "pop" noise go away?

1	Steering Column Assembly
2	Column Tilt/Telescopic Lever
3	Steering Column Tube

4	Stopper Pin "Cam"
5	Steering Column Inner Jacket

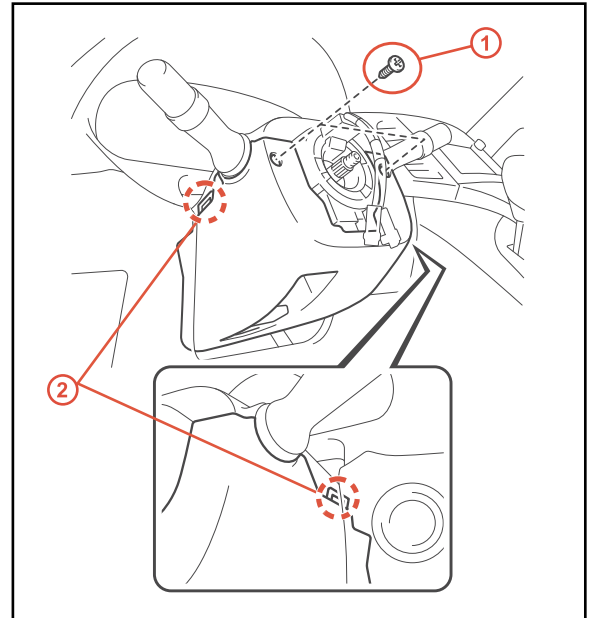
Figure 2.

1	Screws
2	Claws

2. Remove the lower steering column cover.
 - A. Remove the 2 screws.
 - B. Push the right and left sides of the lower steering column cover, and disengage the 2 claws.

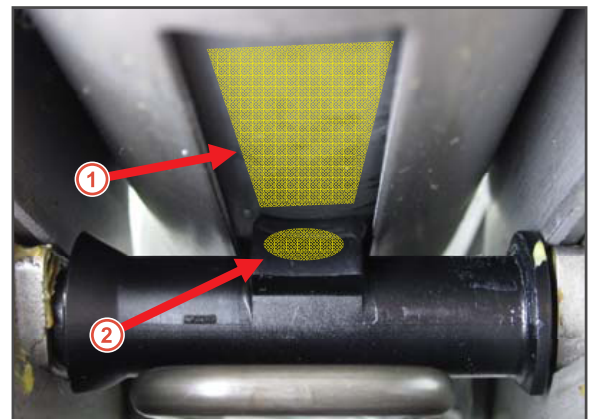
Figure 3.

1	Apply Grease to Column Inner Jacket
2	Apply Grease to Stopper Pin "Cam"

3. With the column tilt/telescopic lever released, fully extend the column telescope towards the driver's seat and tilt column up to the highest tilt position.
4. Using the syringe from the grease kit, apply grease to the column inner jacket and the stopper pin "cam".

Grease Amount:
Column Inner Jacket: 0.3 – 0.4 ml
Stopper Pin Cam: 0.2 ml

5. Cycle the steering column telescope (extend and retract) 10 times to distribute grease evenly.
6. Engage the column tilt/telescopic lever.
7. With the vehicle in Park and engine running, confirm that NO noise is present by cycling the steering wheel from right lock to left lock several times.
 - A. If noise still occurs, inspect for distribution of grease over areas shown in Figure 3 and apply additional grease as necessary.

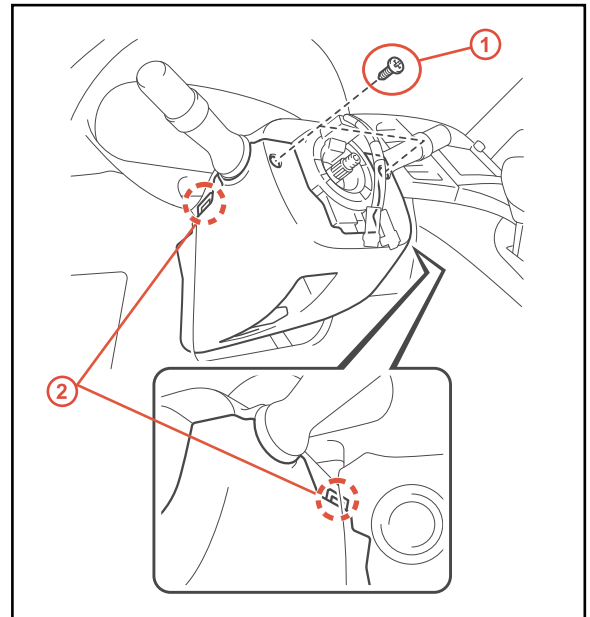
- B. If noise is no longer present, reinstall the lower column cover. **Figure 4.**

1	Screws
2	Claws

- (1) Engage the 2 claws to install the lower steering column cover.
- (2) Install the 2 screws.

Torque: 2.0 N*m (20 kgf*cm, 18 in*lbf)
