# Power Back Door Does Not Close Properly

YEAR(S)	MODEL(S)	ADDITIONAL INFORMATION
2008 – 2012	Highlander, Highlander HV	WMI(s): 5TD, JTE

## Power Back Door Does Not Close Properly

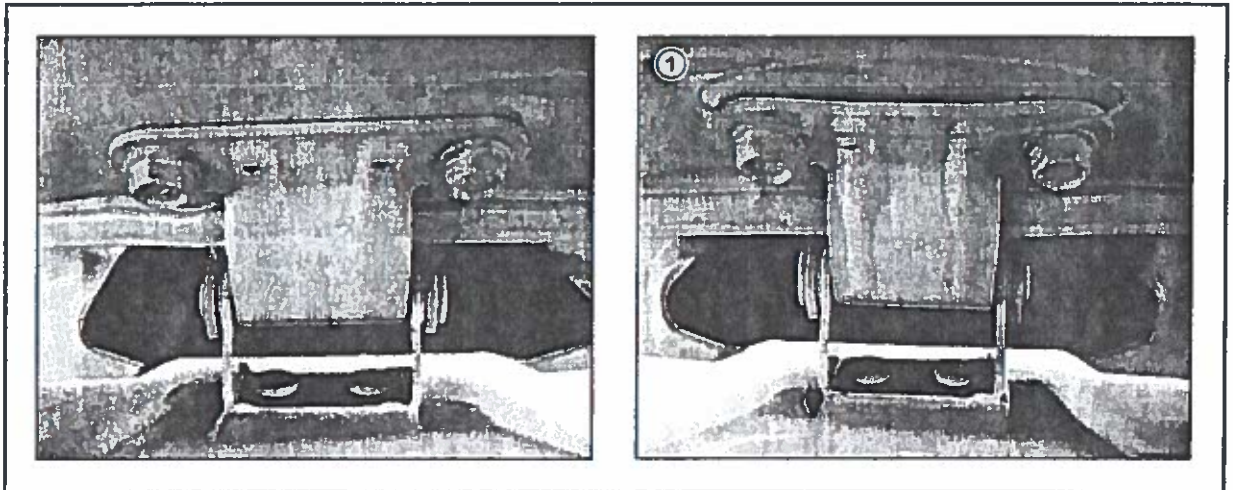
1. Inspect the upper hinges for any gaps present by placing a 0.05 mm (0.002 in.) or greater feeler gauge between the 2 bolts mounted to the back door as shown in Figure 1. If a gap exists, replacement of both Back Door Hinges AND the Back Door Panel Sub-assembly is required. Proceed to step 2.

1	Gap Location
---	--------------

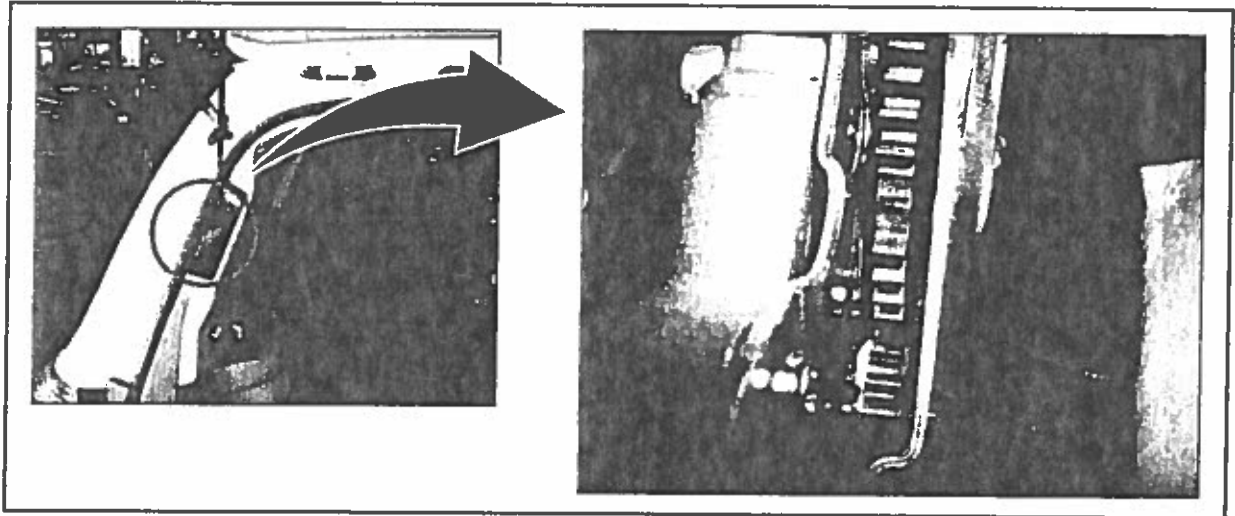
2. Visually inspect the back door motor teeth for damage by opening the back door and manually moving the door towards the half-closed position while observing the large gear teeth for damage, as shown in Figure 2. If damage is found, replacement of the Back Door Motor Unit is required.

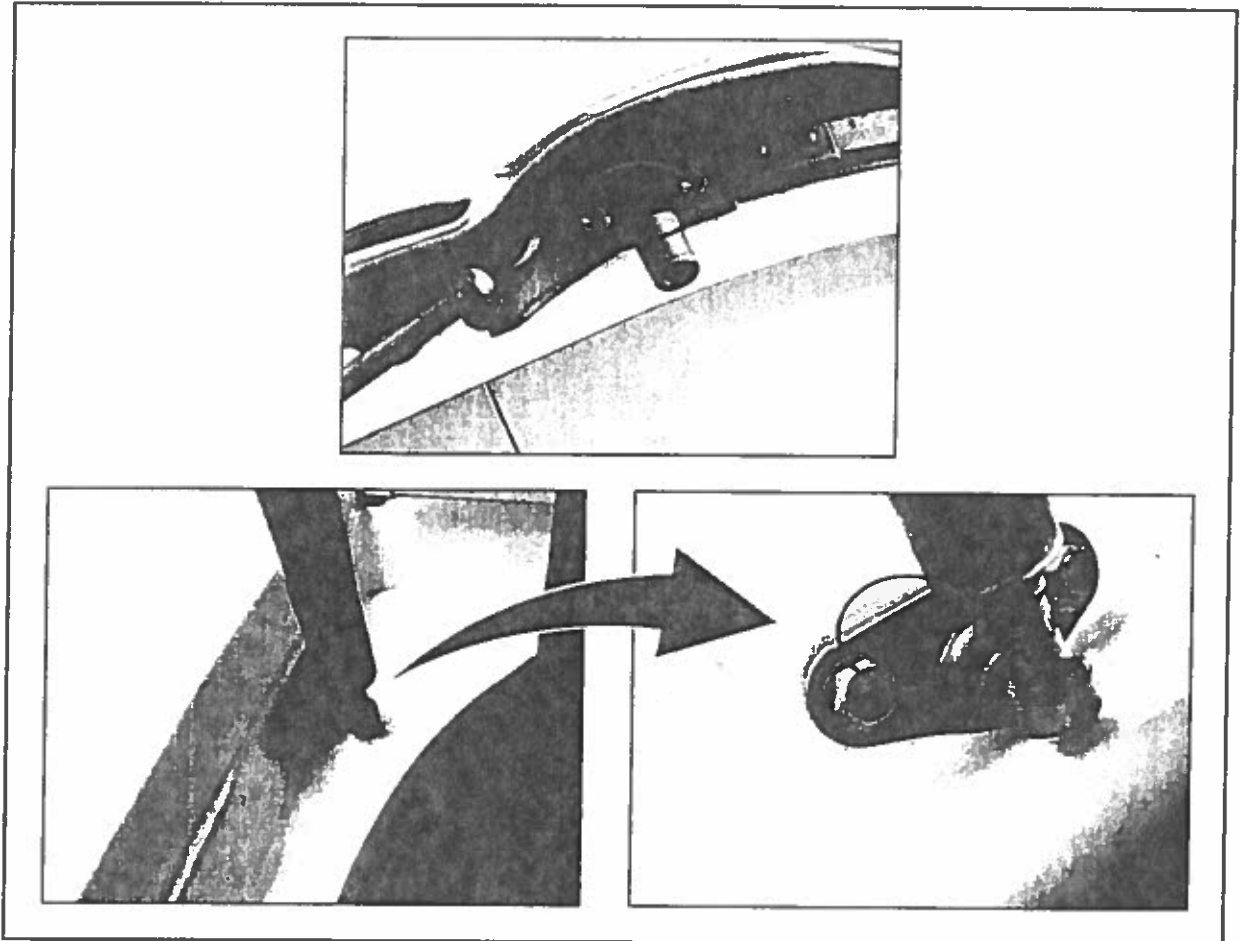
Figure 4.

To ensure correct installation of the back door struts, note the markings on the assembly (Figure 4). The markings indicate on which side of the car the strut should be installed, and the direction of the braces on the strut.
