Integration Relay Poor Ground

YEAR(S)	MODEL(S)	ADDITIONAL INFORMATION
2013	ES300H	
2013	ES350

Some 2013 model year ES 350 and ES 300h vehicles may exhibit a condition where the passenger headlight and rear defogger operate continuously.

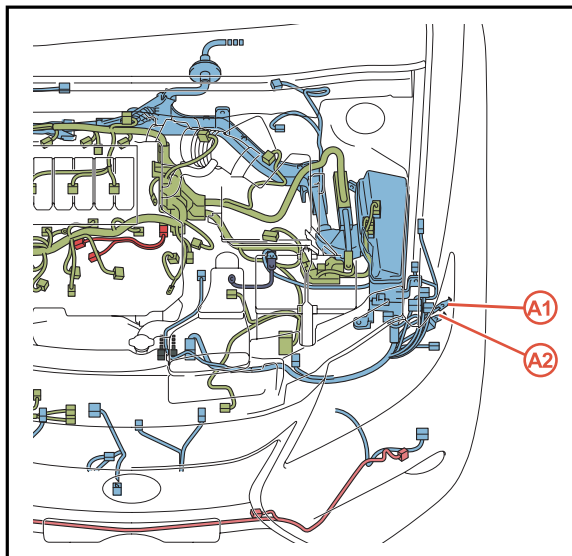
Figure 1.

A1	A1 Ground
A2	A2 Ground

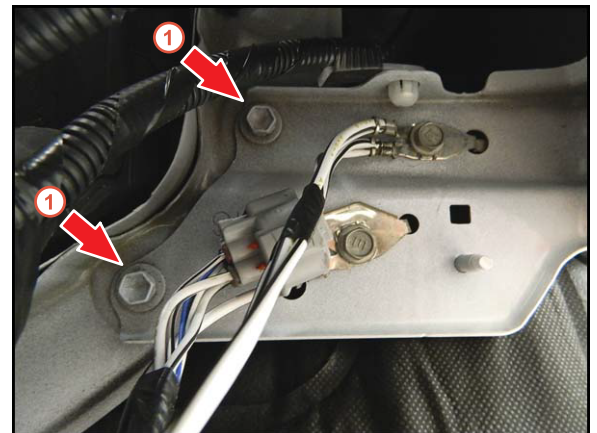
Figure 2.

1	Apron Bolts
----------	-------------

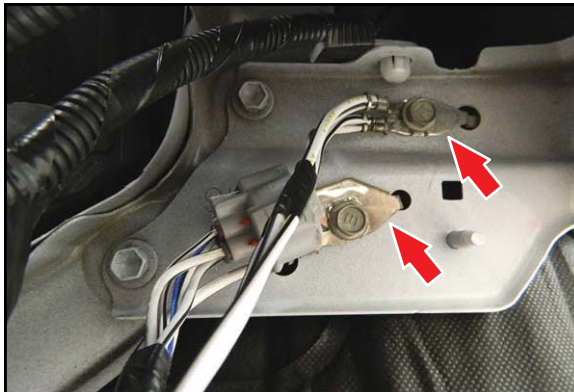
Figure 3.

7. Perform voltage drop test* from the two left fender bracket ground wire eyelet tabs to body ground (see Figure 3).

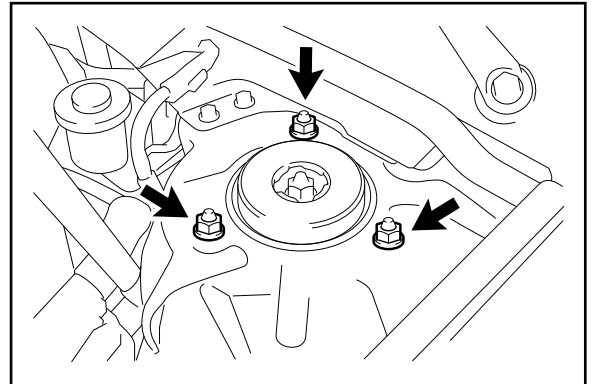
Figure 4.

- A. Use a left front strut tower mounting bolt as a good body ground (see Figure 4).
- B. To perform voltage drop test, connect the negative lead of the DVOM to the strut tower bolt, and the positive lead to the ground wire eyelet tab.

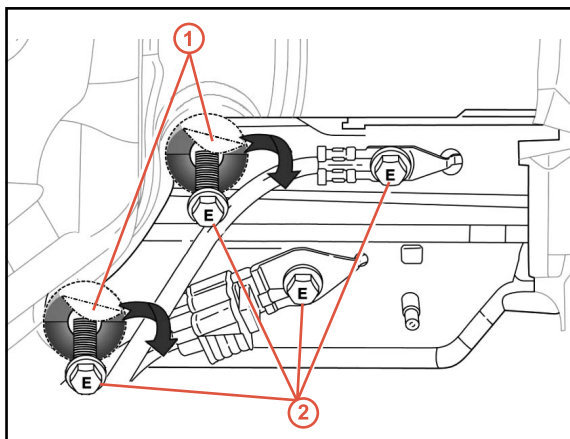
Figure 5.

- Ground bolts are “E” bolts (see Figures 5 and 7).
- Apron bolts should be “E” bolts if left hand fender bracket has been replaced (see Figures 5 and 7).
- The area around the bracket to apron mounting bolt holes (see Figure 6) is free of paint.
- The area around the apron mounting bolt holes do not show masking tape or painted masking tape (see Figures 5 and 6).

1	Confirm Green Masking Tape Is Removed
2	Confirm “E” Bolts Are Installed

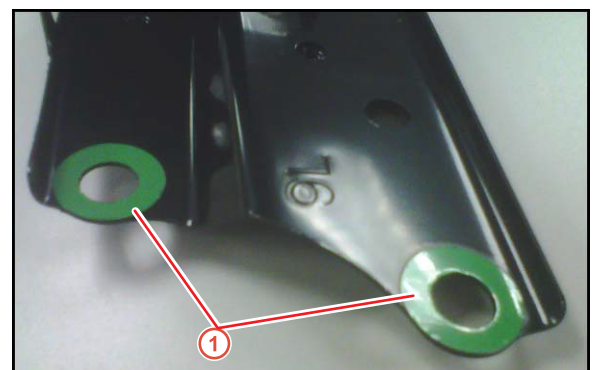
Figure 6.

1	Masking Tape — REMOVE After Painting, NO Paint in This Area
----------	---

- It is important that the bracket to apron mounting bolts/washers are free of paint on the front portion of the bracket.
- The new part number bracket comes with instructions that should be followed carefully when replacing.
- The new bracket also comes with green tape around the apron mounting bolts to protect it during the painting phase (see Figures 5 and 6). *This green masking tape MUST be removed in order for the bracket to be properly installed on the vehicle.*
- The new bracket includes new apron “E” mounting bolts. It is important that the new “E” bolts are used and are torqued properly. See Figure 7 on how to identify new bolts.

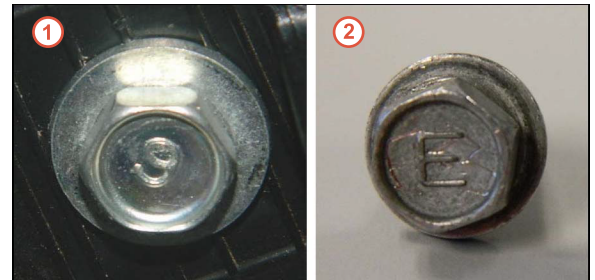
Figure 7.

1	Old Bolt: DO NOT USE or Reuse These Bolts
2	NEW “E” Bolt

Torque: Ground Bolts:
 6.9 – 9.8 N*m (70 – 100 kgf*cm,
 5.1 – 7.2 ft*lbf)

Torque: Bracket to Apron Bolts:
 3.9 – 8.8 N*m (40 – 90 kgf*cm,
 2.8 – 6.5 ft*lbf)
